## Experimental Study of Fatigue Crack Behavior of Rib-To-Rib Butt Welded Connections in Orthotropic Steel Decks

### Abstract

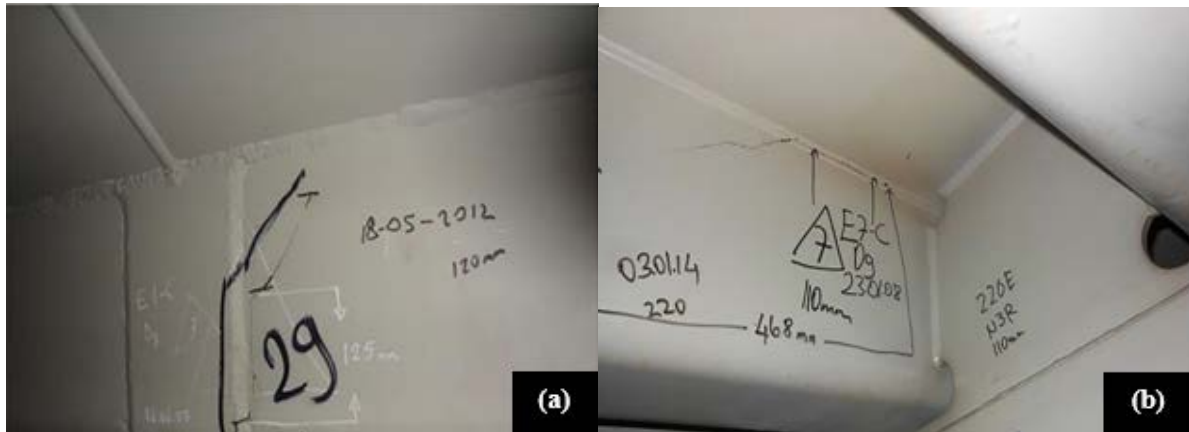
**Figure 1:** Fatigue cracks in trapezoidal longitudinal rib: (a) initiated at the welded joint, and (b) propagating to the rib wall.

Furthermore, as illustrated in Figure 1, several fatigue cracks were found in the Fatih Sultan Mehmet Bridge in Istanbul, Turkey, the main goal of this research coming out of this finding. Fatigue cracks have been discovered and identified, and have gradually increased in OSDs, generally originating from and occur due to repeated out-of-plane bending owing to repeated wheel loads. These fatigue cracks generally initiate at welded joints that exist between connection plate and trough rib and subsequently propagate to the rib wall. Such fatigue damage may cause a sudden decrease in the longitudinal rib stiffness. Out-of-plane bending results in high local flexural stresses in the welded joints between the connection plate and trough rib, because the plate and trough rib thicknesses are relatively small.

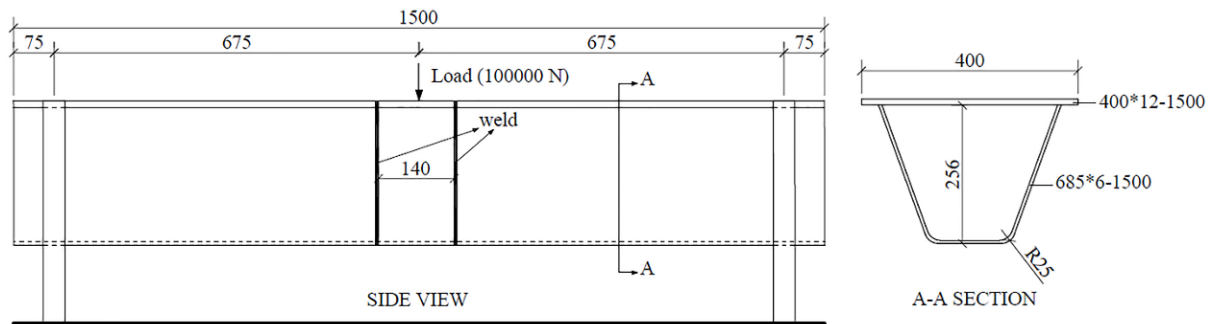
**Figure 2:** Trapezoidal longitudinal rib details (dimensions in mm).

The trapezoidal longitudinal rib examined in this study is illustrated in Figure 2. The cross-sections of the rib studied in this case were taken similar to that of existing ribs (Figure 1) used in the Fatih Sultan Mehmet Bridge in Istanbul (Brownjohn, Dumanoglu and Severn, 1992). The connected rib part is 1500 mm long and has a depth of 256 mm. The deck plate is 400 mm wide and its thickness is  $t_d = 12 \text{ mm}$ . Rib has a trapezoidal section as shown in Figure 2 with a plate thickness of  $t_r = 6 \text{ mm}$ . Two 675 mm main ribs are welded and connected with a 140 mm central rib. The arc curvature radius of each rib measured 25 mm. The part is supported from the edges and loaded at the middle of the span as in a three-point bending formation.

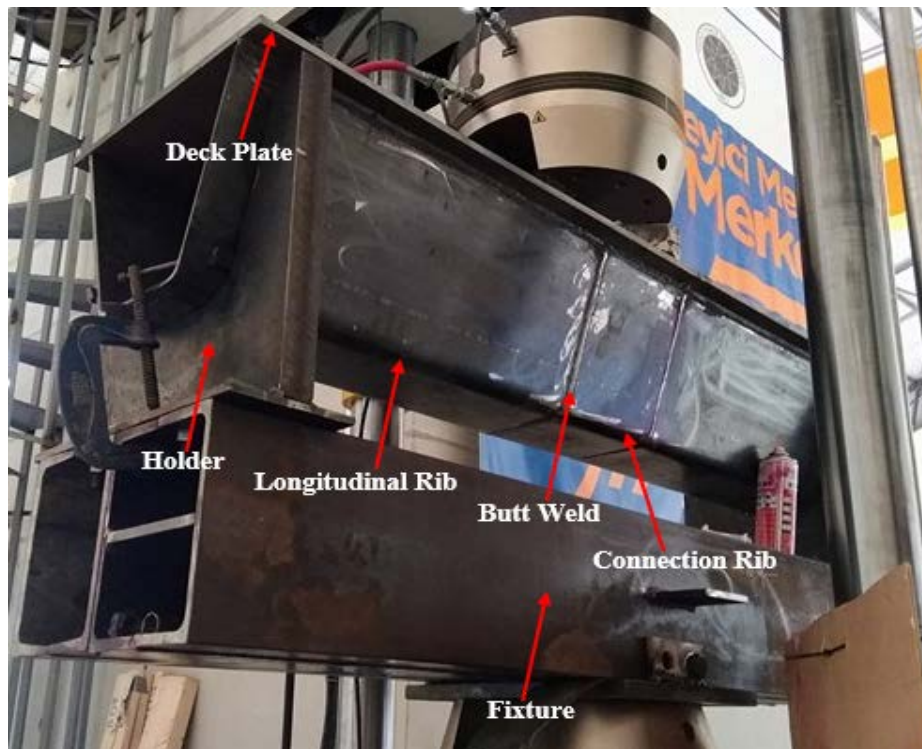
**Figure 3:** Experimental specimen details.

According to the drawing in Figure 2, in the experiment, six full-scale (RR) butt-welded connections were manufactured. Each specimen is formed with a deck plate, two trapezoidal ribs, and a connecting rib as details were given. The legs of the ribs were welded to the deck plate using PJP, while complete joint penetration (CJP) was applied at the RR connection edges. This was carried out using carbon dioxide gas arc welding, in strict accordance with the American National Standard Welding Code (2011). The details of a typical specimen are illustrated in Figure 3.

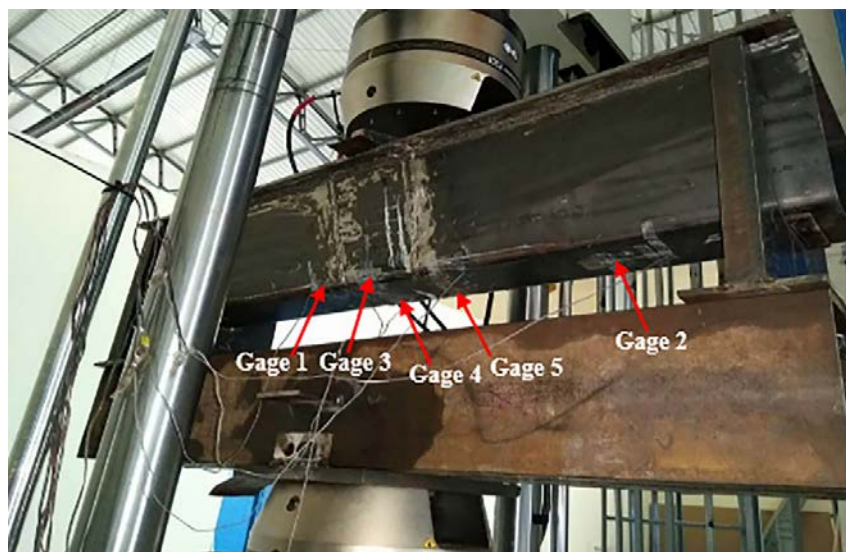
*Figure 4: Gage installation in field.*

Five strain gages were attached to the control specimen from the rib bottom side in the longitudinal direction in order to measure the strains near the (RR) butt-welded connections, as illustrated in Figure 4. The first step (considered to be the most important step in strain gage installation) was surface preparation, which was necessary to produce a chemically clean surface with appropriate roughness, alkalinity, and layout lines. The surface preparation was performed in accordance with the Vishay (2009) Micro-Measurements Application Note B-129-8. A static load was successively applied to the specimen. While the static test was being performed, specimens were loaded within the elastic range and the monotonic load was gradually raised to its maximum value in several equal-sized load increments/steps. A load of 100,000 N was applied at the center of the specimen and strain values were obtained at each gage locations.

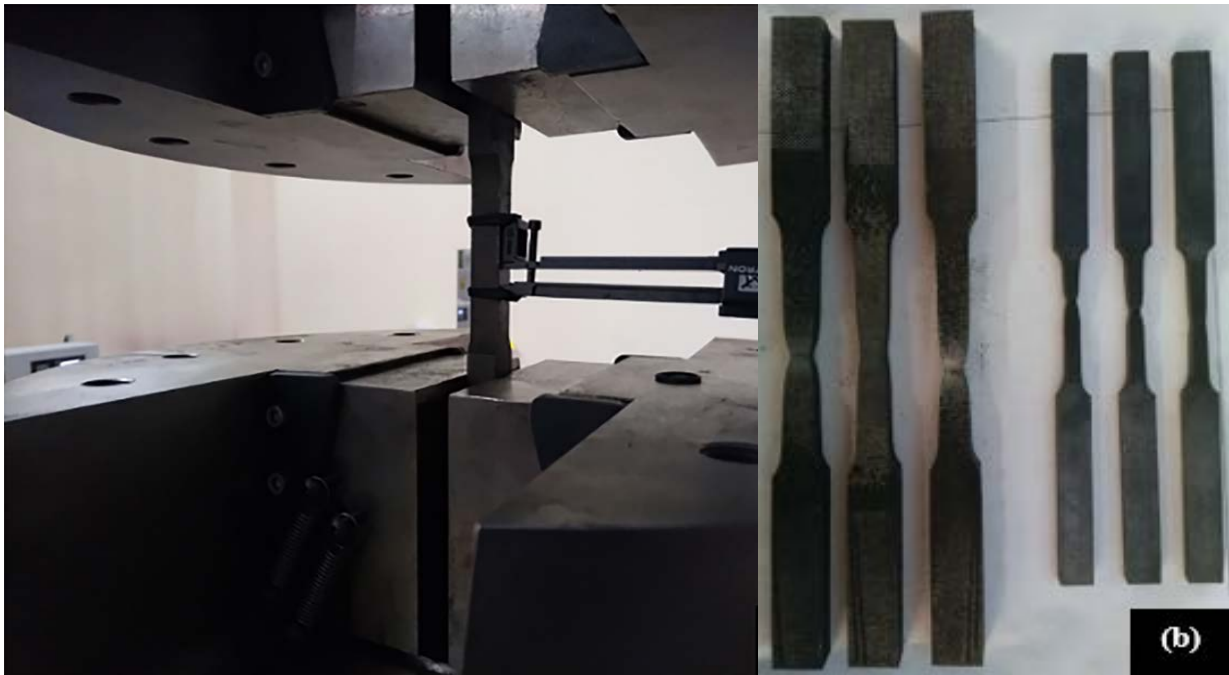
**Figure 5:** (a) Coupons while testing, and (b) coupons geometry following test.

All of the plates used to manufacture the specimens were S235 steel material. Following static calibration and dynamic fatigue tests, tensile testing coupons were cut from the web (rib steel plates) and flange (deck steel plates) of specimen 2. The rib coupons (RC1 through RC3) had a 6 mm test thickness, while the deck coupons (DC1 through DC3) had a 12 mm test thickness, and the tests performed in accordance with ASTM E8/E8M (2009). The measured material properties are shown in Table 1, which indicates the modulus of elasticity (E), yield stress (F<sub>y</sub>), and ultimate stress (F<sub>u</sub>). The test was conducted using an Instron machine, as illustrated in Figure 5.

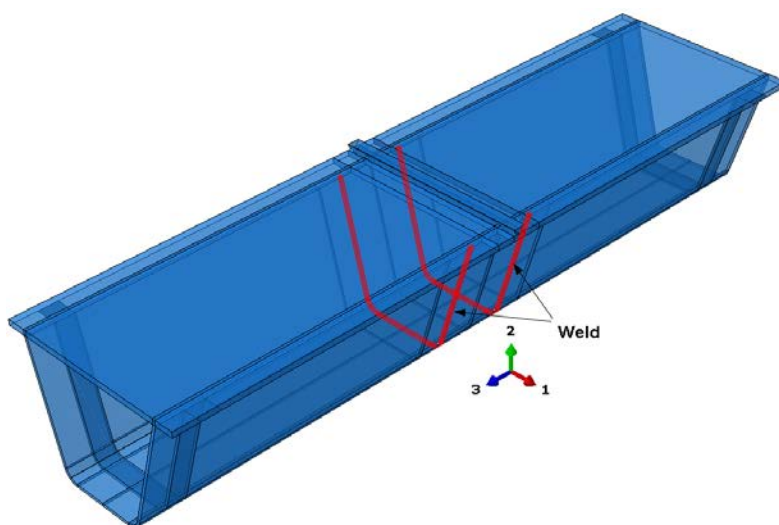
**Figure 6:** Trapezoidal longitudinal rib with connection region.

The connections between the longitudinal rib and deck plate were modeled using a tie constraint in the analysis. Also the interaction among the connection rib, weld, and longitudinal rib were selected as tie constraint to provide the full connection. Hard contact interaction and friction were defined between the loading rod and the deck plate. The holders and the support assembly are assumed to be rigid and only the holder parts are modeled with discrete rigid elements as can be seen in Figure 6.

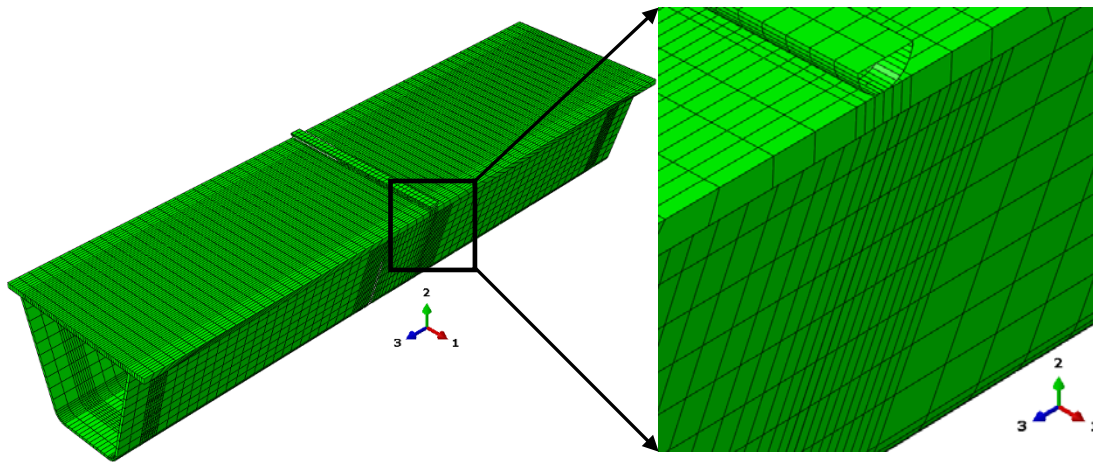
*Figure 7: Finite element assembly mesh with target connections.*

Metal plasticity is used in the analysis despite the load level was not over the elastic range. Thus yielding and other nonlinear effects were of no interest (Håkansson, 2015). Except for the target connections which include the connections rib, welds and a small part of the longitudinal ribs in the middle of the model, the mesh size for the entire model was approximately 25 mm. The mesh size in connection regions were selected at 5 mm. Eight-node linear brick element (C3D8R) defined for the whole mesh element type, as illustrated in Figure 7. An axial load of 100,000 N of concentrated force was applied to the center of the deck plate. This is considered the maximum load of one wheel when a truck is fully loaded with a dynamic amplification factor.

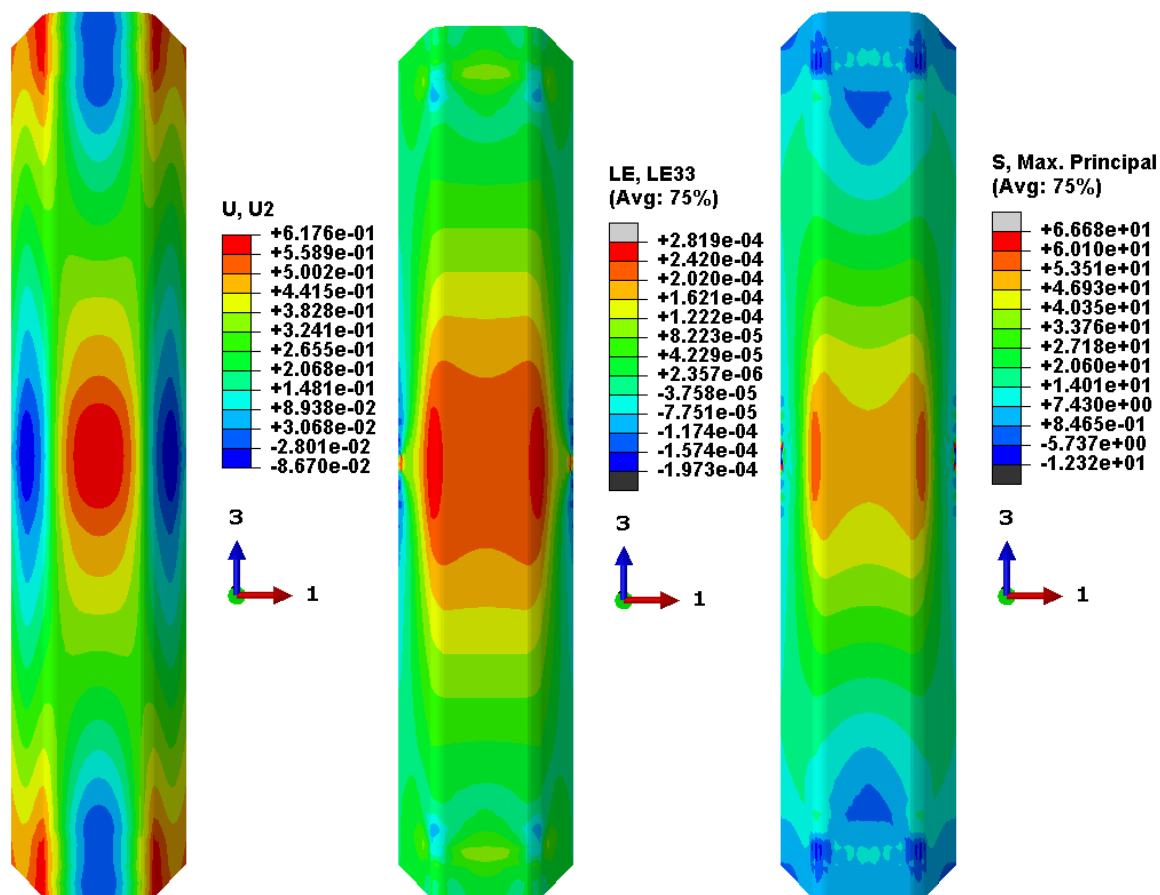
**Figure 8:** Vertical deflection ( $U_2$  - mm), Longitudinal strain ( $LE_{33}$  - mm/mm), Maximum principal stress (MPa) contours.

As expected bottom path of the rib was subjected to the maximum principal stresses, deflection, and deformations compared to the other system components when the load is applied at the middle of the rib. It is also seen that the weld stresses around the connection rib were concentrated, and the connection region could be susceptible to fatigue type cracking. The stresses on the trapezoidal ribs exhibited a single-sign stress distribution, particularly the compression region along the force direction. Moreover, the maximum deformation locations were close to the bottom side of the trapezoidal rib, as indicated in Figure 8. This result reveals the places where the cracks most probably began to grow, as illustrated in Figure 1.

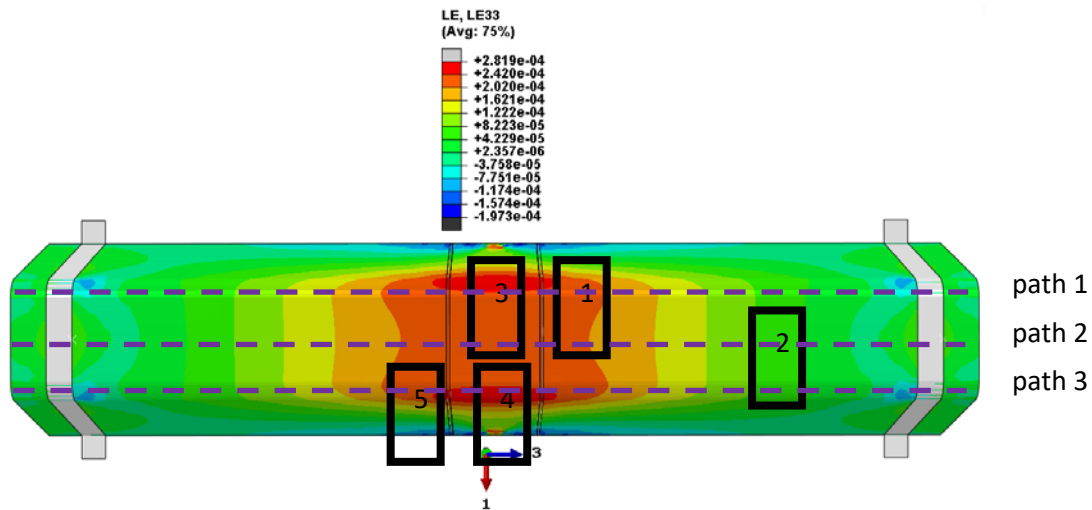
Figure 9: Location of strain gages.

The main point of the numerical approach in this study was to determine the strain values in the same strain gage positions that were fixed on the specimen in the experimental static loading test so that set up can be verified. The three different longitudinal paths that were examined numerically are illustrated in Figure 9. These paths were taken along the bottom of the model, which considered the most critical locations and would be exposed to the greatest deformations. Path 1 passed through Strain Gages 1 and 3, Path 2 passed through Strain Gage 2, and Path 3 passed through Strain Gages 4 and 5. The details for these gages are displayed in Table 2.

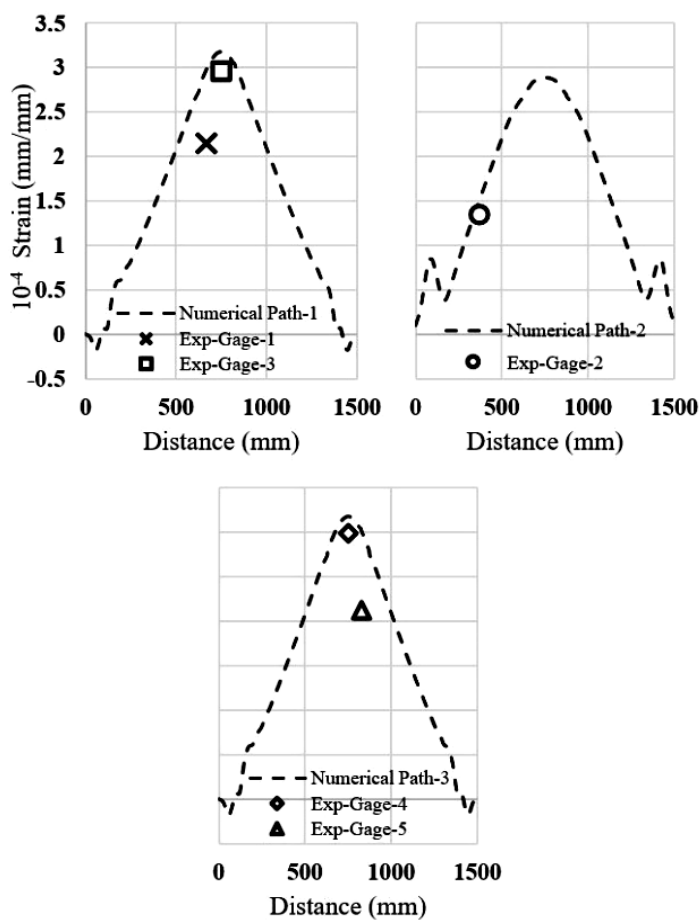
Figure 10: Comparison of strain gage values of numerical and experimental approaches along longitudinal paths.

As can be seen from Figure 10 strain data correlates well with the numerical model and all assumptions made for rigid parts can be considered realistic. This also shows that the holder fixture does not have any effects on the experiment. Thus cyclic test indeed will reveal true fatigue characteristics of the RR butt connection.

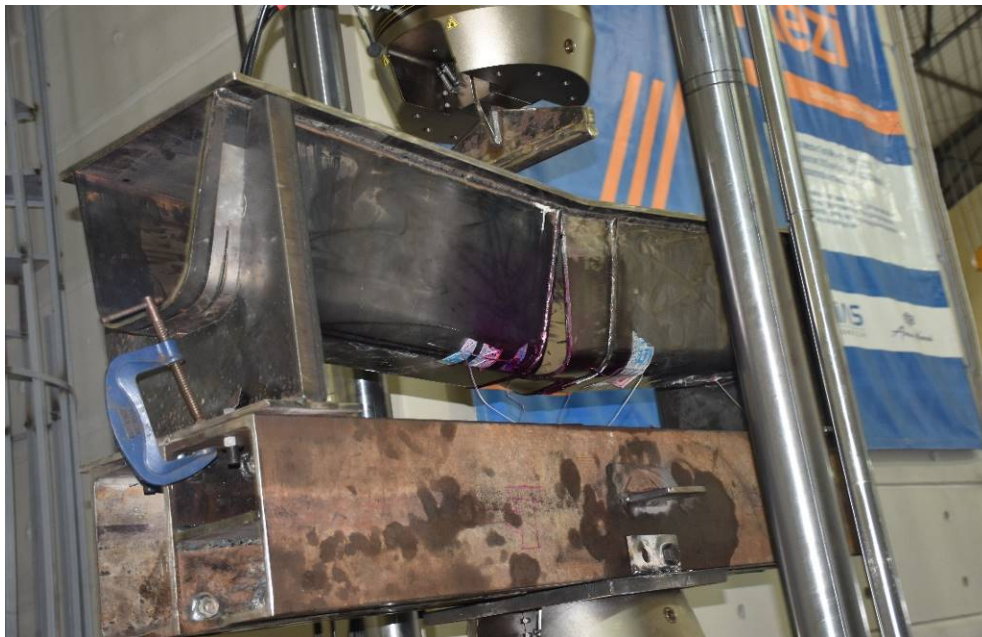
*Figure 11: Failure mode at the bottom of the rib.*

Fatigue cracks at the (RR) butt-welded connections were mainly caused by out-of-plane bending, which is the mode I loading. The failure modes of the five trapezoidal rib specimens with initial cracks were similar, represented by an opening mode at the bottom of the ribs and indicated by local displacements that are symmetric with respect to the x-y and x-z planes, and the two fracture surfaces were displaced perpendicular to one another in opposite directions (Barsom and Rolfe, 1999). Figure 11 illustrates the typical failure modes of the five specimens with initial cracks, where fatigue cracks were all observed on the butt-welded connections, generally near to the center of the rib arc.

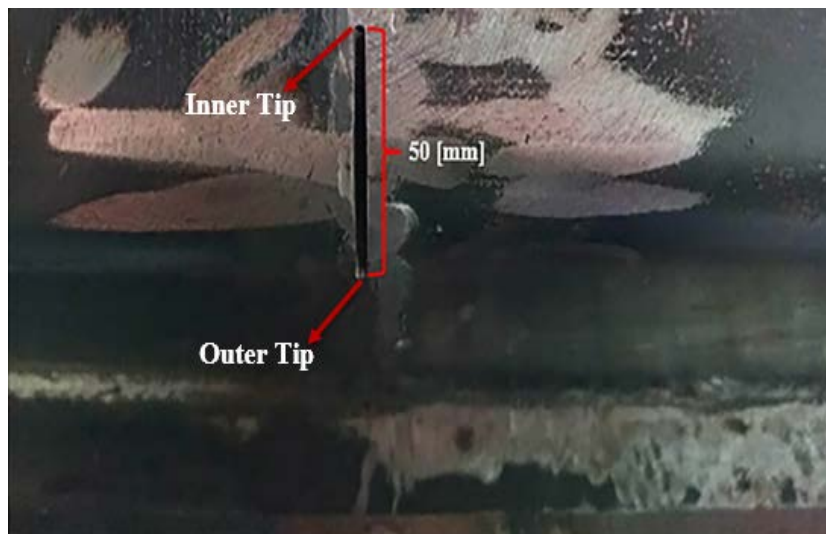
*Figure 12: Initial crack at transverse butt-welded connections.*

**Phase I:** An initial crack with a length of 50 mm and a depth of 6 mm is manually created at the center arc of the butt weld on one side of the connection from the bottom of the rib for the five trapezoidal specimens by using a cutting tool, as shown in Figure 12. The main reason for implementing the initial crack is to reduce the dynamic fatigue test time. It had been found that the control specimen reached 1.2 million cycles, which is more than ten consecutive days of continuous examination without any noticeable cracks, following which the test was stopped. The secondary reason is that it may be easier to investigate the propagation characteristics of possible rib cracks. Therefore, the determination of cracking became more accurate and cracks could be observed with the naked eye.

Because the study focused on the areas around the initial crack tips, these were manually adjusted according to the crack growth during the entire test process, by using either the dye-penetrant or dynamic stiffness crack detection method, both of which were implemented in this study. The crack initiation locations are consistent with the highest stress concentration that were identified from the static calibration test and computer simulations.

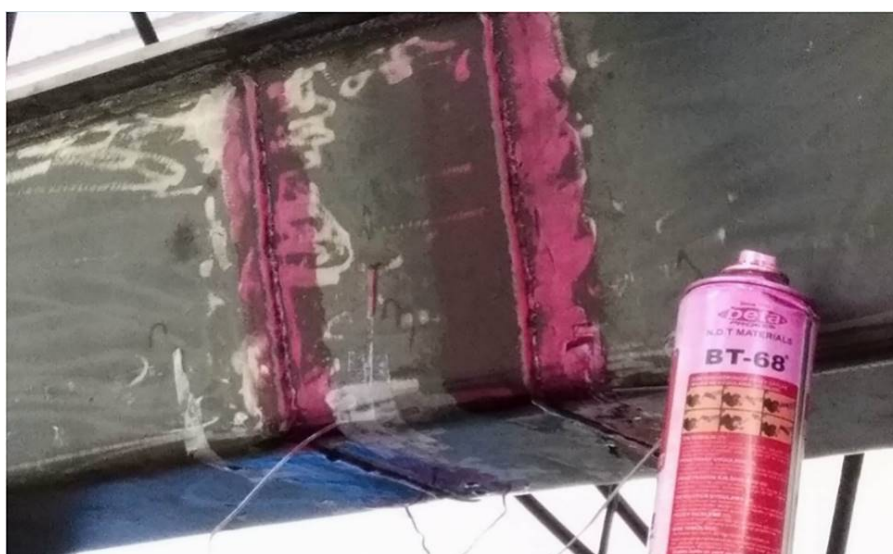
*Figure 13: Detection of crack propagation using a dye-penetrant method.*

**Phase II:** As the cyclic loading continued, the crack steadily propagated away from its two tips, up to the outer tip proximal to the terminating point of the rib wall, and finally reached the rib edge. The paths of the crack growth at all times continued along the toes of the butt weld on the rib. Relative to other states, the rate of the crack growth during this phase was low, and the inner tip propagated faster than the outer tip because of the direct effect of cyclic loading. During this propagation phase, as their opening widths gradually enlarged, the cracks had become increasingly visible to the naked eye when using dye-penetrant crack detection, as illustrated in Figure 13. The test was monitored and the specimen was inspected for possible fatigue cracking at regular intervals. In the dye penetrant method, the procedure recommendations were firstly achieved by spraying BT68 spray onto the specimen on the parts where cracks were expected to occur, the function of which is to penetrate inside the cracks rapidly. Repeated spraying BT69 served to clean only the surface part that was sprayed with BT68, following which it was wiped dry with a cotton cloth. The use of these two sprays made the cracks visible to the naked eye, and the method was applied without stopping the test. This phase concluded upon the onset of cracks appearing on the top surface of the butt-welded connections, and the displacements of the maximal crack openings on the butt-welded connection of the rib bottom surface were found to be up to 1mm.

Variability in the length of the cracks, as can be seen on the rib bottom surfaces and butt-welded connections during the test, is illustrated in Figures 13 and 14. It is evident that the cracks continued to increase in vertical length from initiation until the end of the test, and there were no obvious distinguishing boundaries between the three previously described cracking phases. Moreover, the rate of the growth in crack length (curve slopes in Figure 15) constantly increased while the test was occurring, implying that the stress intensity factors at the crack tips increased with an increase in the length of the crack (Fu et al. 2017). Normally in the early phase, approximate linear increases in crack length were observed with the number of cycles before the outer tip of the crack arriving at the top edge of the rib. The crack growth rate afterward started improving with the continuation of the cyclic loading. Moreover, the crack quickly extended in its vertical direction until the final length accumulated to several times the length of the edge crack.

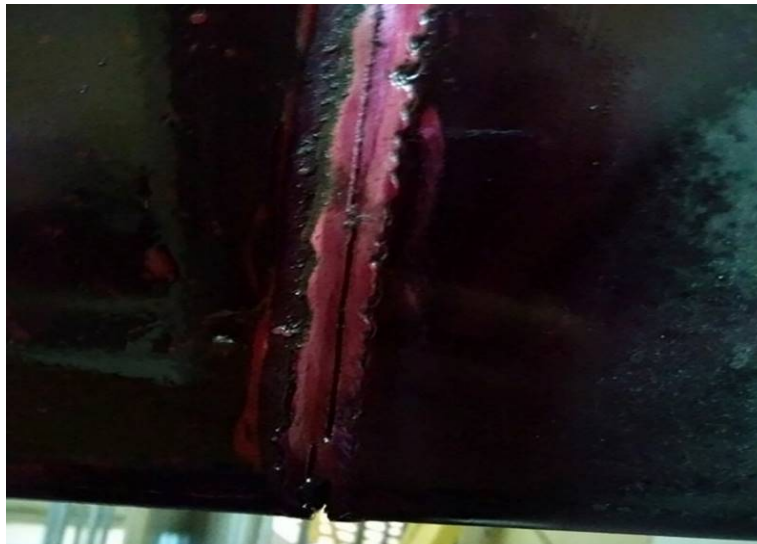
*Figure 14: Extended fatigue crack thickness along butt-welded connections.*

**Phase III:** The outer tip of the crack had to propagate along the thickness of the butt weld, and finally ran through it. The crack depth measured at this location increased rapidly as the cyclic loading was repeated, and the inner tip of the crack continued to extend forward at a high speed. The outer tip of the crack, which ran through the thickness of the weld, was extended in the vertical direction perpendicular to the loading axis (towards the inner tip) step by step and increasing crack parts ran through the weld. Consequently, parallel to the weld joints, a visible longitudinal crack formed on the wall and bottom surface of the rib plate, and the measured opening widths were up to 5 mm, as seen in Figure 14.

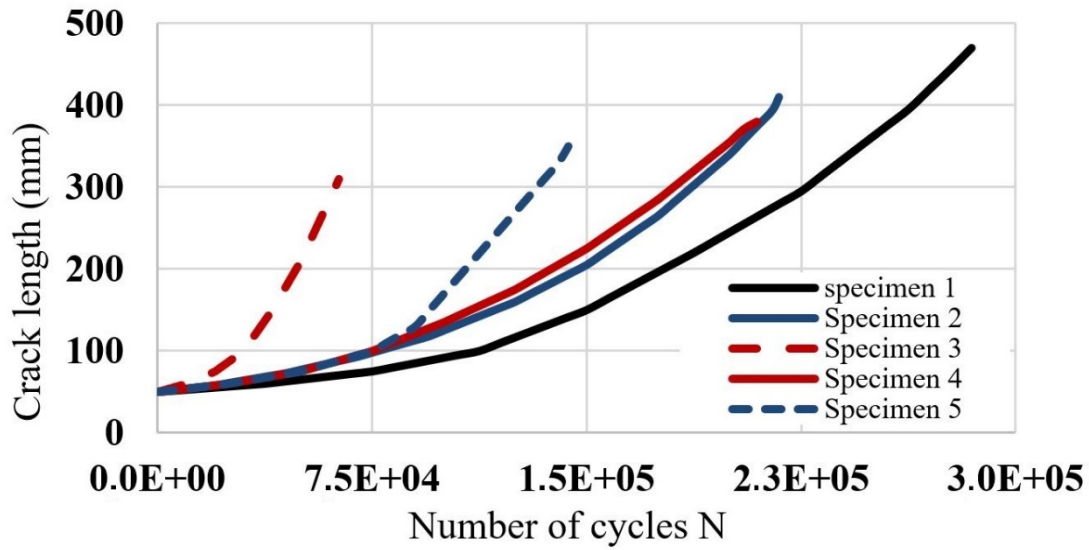
Figure 15: Crack length versus number of cycles ( $R = 0.1$ ).

At a certain number of cycles (7,500), the crack began to propagate when it was 2 mm in length. Crack location investigations were performed using the dye-penetrant method, as mentioned previously, following which the cracks were monitored and registered manually versus every 5,000 cycles until the specimen was exposed to fatigue issues. The crack growth began from both surface edges of the initial crack, where the maximum bending stress was generated and penetrated to the center of the weld thickness. Once the crack had begun to penetrate to the weld thickness middle, the curve of crack growth at the center of the weld connections was almost parallel to the weld stretch shape, indicating that the growth rates of the crack at the center and weld stretch shape were nearly identical. The measured propagation of the crack lengths and cycle numbers of the cracks for each specimen are listed in Table 3.

Two methods of crack detection revealed quite similar characteristics in their own terms. For example crack size- number of cycles graph of Dye-Penetrant method in Figure 15 shows a sudden jump in crack growth rate around  $10^5$  cycles whereas crack stiffness-number of cycles graph of dynamic crack stiffness detection method in Figure 16 shows a sudden loss of stiffness at the same number of cycles ( $10^5$ ).

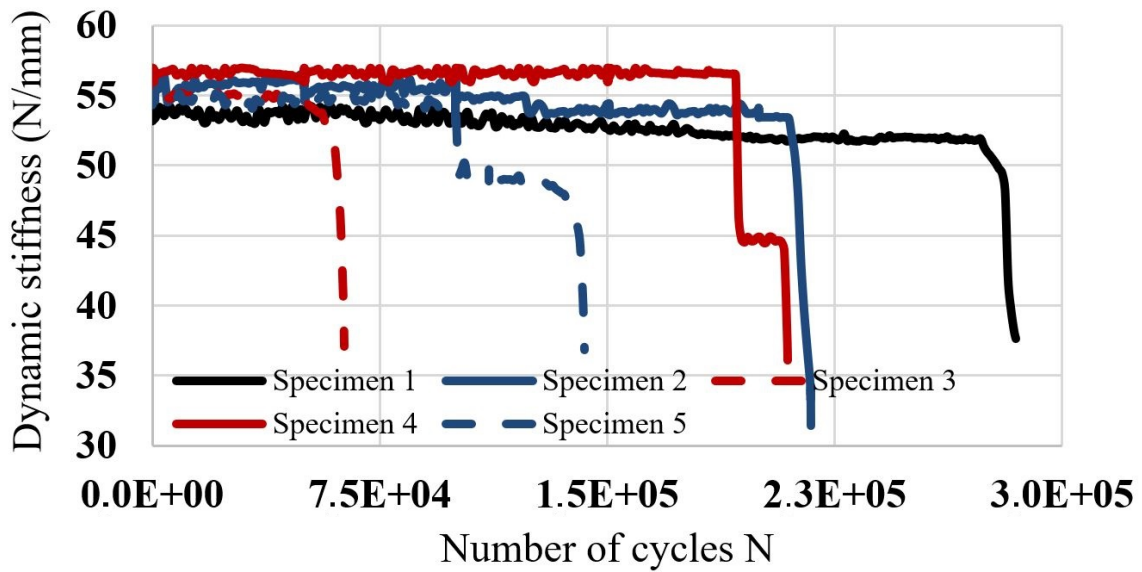
Figure 16: Dynamic stiffness versus cycles for cracked specimens

A decrease in dynamic stiffness was demonstrated to be a direct indication of fatigue crack growth. The fatigue crack propagation could be predicted by recording and monitoring changes in the dynamic stiffness of a specimen throughout the fatigue test duration of a fatigue test. Moreover, Figure 16 presents the stiffness values versus every cycle during cycling load until fatigue. It was observed throughout the cycling load that the change in the stiffness value was small and almost a straight line, but the value suddenly changed downwards, which means that the specimens with initial cracks failed (Kaan et al. 2012). However, as seen in Figure 17, the stiffness line for the control specimen still does not exhibit any slope change, indicating that no noticeable cracks appeared during the test.

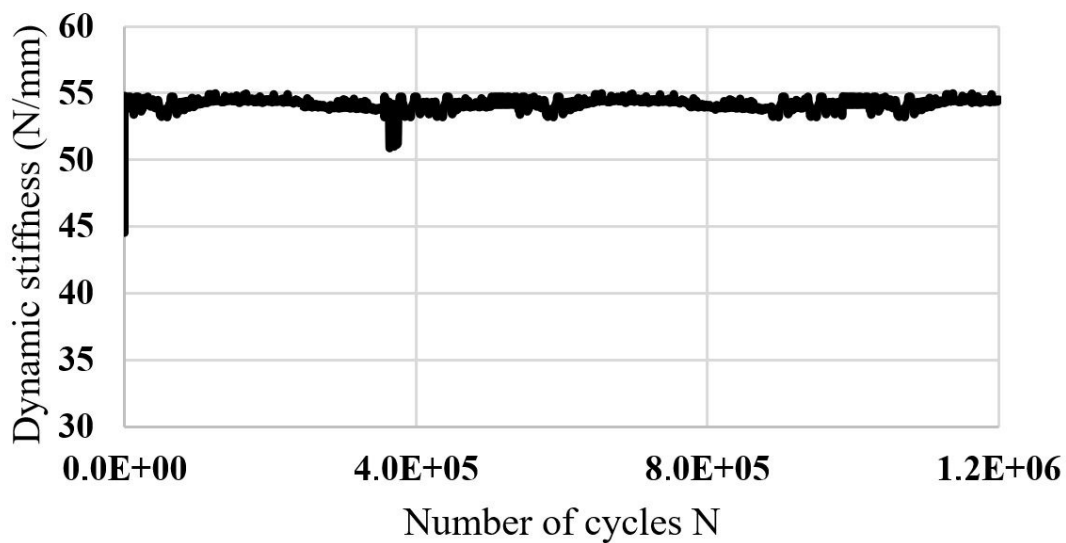
**Figure 17:** Dynamic stiffness versus cycles for the control specimen

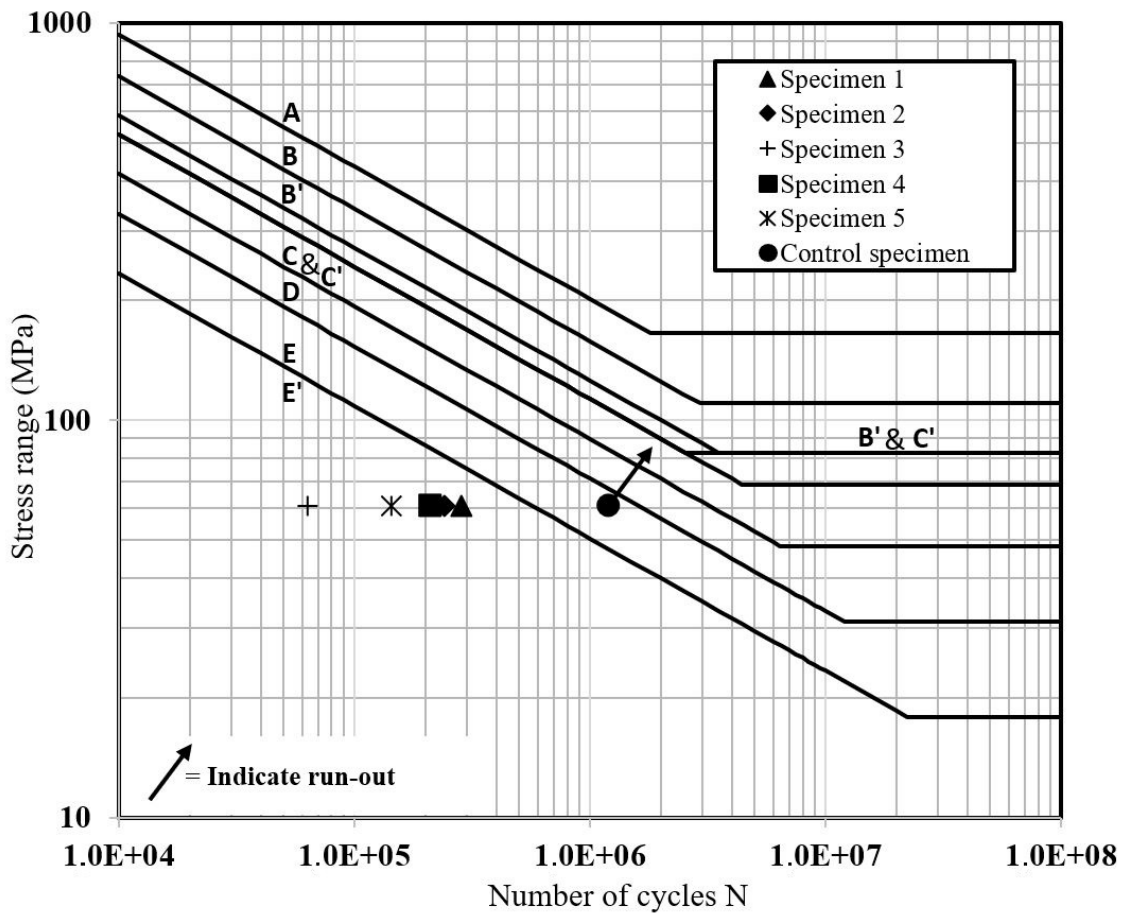
Figure 18: S-N diagram illustrating results of testing of six trapezoidal ribs in AASHTO (2007) fatigue curves.

As failure was predicted to occur at the weld connections, all specimens were tested at a nominal stress range of 60.772 MPa, taken at the center of the butt-welded connections from the rib bottom side with 100,000 N of applied loading. Where the stress range was too small, the maximum stress state was taken from the actual state and not selected as being higher. Each of the specimens with initial cracks exhibited markedly shorter fatigue lives than the control specimen that was tested within the same stress range. Figure 18 presents this effect and shows how it indicates the number of cycles accumulated for each specimen in the form of an S-N diagram with the AASHTO (2007) fatigue design curves. The S-N curve is a relation between the stress range under constant amplitude loading and the number of cycles until fracture (Alemdar et al. 2012). Specimens with initial cracks underperformed the AASHTO Category E' fatigue curve by a significant margin, which may be explained by the lowest fatigue strength quality of the welds alone at the bottom of the ribs.
