Seismic Upgrading of Exterior Reinforced Concrete Frame with Small Column and Joint Area Using Externally Attached Steel Column

Abstract

beam-column joint, seismic strengthening, small column frame

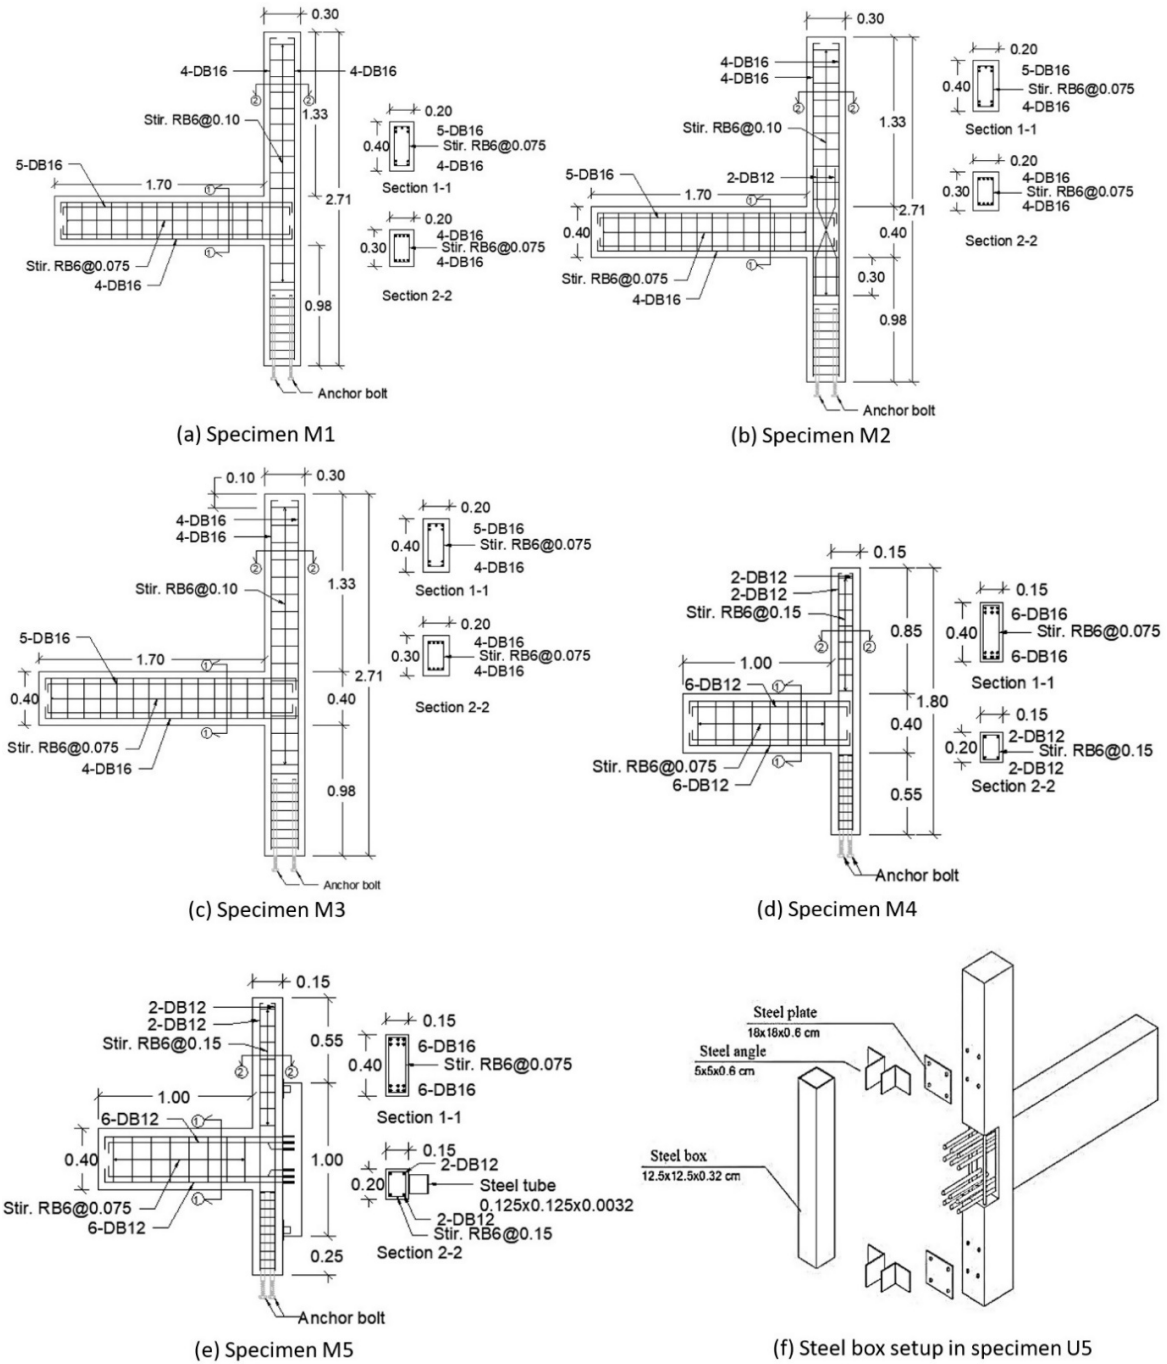
Figure 2: beam-column joint reinforcement detail

There were 5 test specimens as shown in Figure 2. The first four specimens were exterior reinforced concrete frame designed to be failed by the joint shear failure. Their nomenclature starts by “M” letter. The other one specimen was the upgraded exterior reinforced concrete frame. The nomenclature starts by “U” letter. The test specimens were planar beam-column subassemblies representing a portion of the building frame at the exterior joint between column and beams. The cyclic force was applied so that the distribution of the bending moment and shear force in the specimens were the same as for the whole building frame under lateral cyclic loading (Ketiyot & Hansapinyo, 2018). Specimens M1, M2, and M3 were a group of similar test specimens. The only difference was the reinforcement at the joint. The upgraded specimen U5 using attached steel column had sectional dimension and reinforcement similar to M4 specimen. The steel column was a 12.5x12.5 cm square steel box with a thickness of 3.2 mm. Longitudinal reinforcement was SD40 deformed bar either DB12 or DB16 with the nominal diameter of 12 mm and 16 mm, respectively. The stirrup was SR24 round bar either RB6 or RB9 with the nominal diameter of 6 mm and 9 mm, respectively. The tensile test results of the steels are shown in Table 1. At the cast date, concrete cylinders were sampled and tested for the compressive strength at the same date of the frame test. The concrete compressive strengths of the specimens are shown in Table 2.

The first group of specimens comprising of M1-M3 were designed for the joint shear critical to obtain the effect of the different joint detailing. As shown in Figure 2, there was no hoop reinforcement in the joint area for M1 specimen. Three stirrups were provided for M2 specimen and diagonal rebars were arranged for M3 specimen. However, the contribution of the reinforcement is ignored for the determination of the joint shear strength based on chapter 21.7.4 of ACI318 (ACI, 20008), as seen in equation (1), where f'_c and A_j are respectively the concrete compressive strength and the effective cross-sectional area within a joint in a plane parallel to plane of reinforcement resisting shear in the joint. For M4 specimen, the exterior joint had no shear reinforcement resemble with M1 specimen but the column size was smaller. The reinforcement and dimensions of M4 specimen were designed considering strength scaling based on the capacity of the school building frame, as shown in Figure 1. The calculated ultimate story shear was 13.10 kN, as shown in Table 2, with the joint failure mode. For specimen U5, 12.5x12.5x0.32 cm hollowed steel box column was externally attached to the column to increase the column and shear capacity. As shown in Figure 2(f), to attach the steel box into the exterior existing column, two steel plates were attached to the column at the two ends using four drilled bolts. Then, the column was welded to the steel plate. At the beam-column joint, the covering concrete of the hook bar was removed and the hooks of the longitudinal reinforcement were straightened out and welded to the attached steel box. The required strength of the steel box was determined based on the capacity design philosophy. As shown in Figure 3, the capacity for different failure modes are first determined (Steps 1-3) and then calculate the ultimate story shear for the different modes (Step 4). Next, aiming at altering failure to the flexural damage in the beam, the required more strength upgrade for each mode is estimated based on the exiting flexural capacity of the beam. For upgraded specimen U5, the calculated story shear is 33.60 kN, as shown in Table 2, with the failure mode is altered to the shear failure in the column at the section next to the end of the attached steel box. It is noted that, to achieve the alteration of the failure to the beam flexure, the beam shear capacity, column shear and joint shear must be upgraded to a capacity higher than the beam bending capacity by using a larger size of the steel box and extended through the column length.

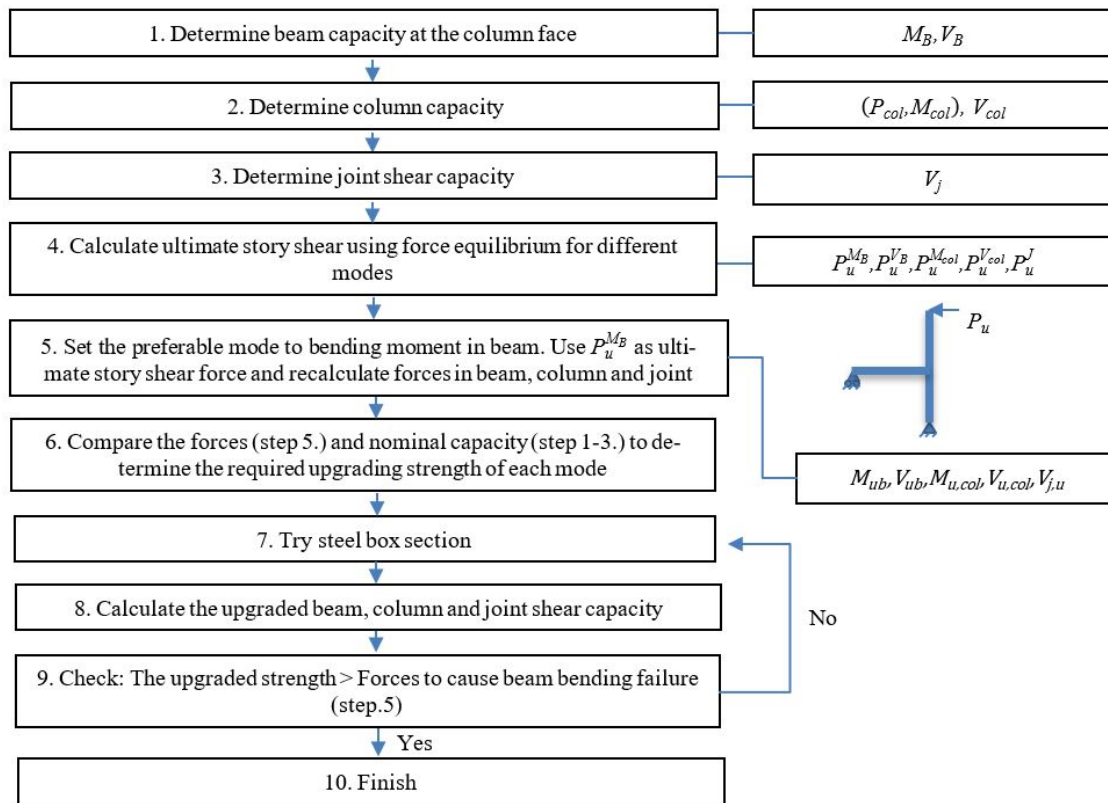
Figure 3: Determination of the steel box section

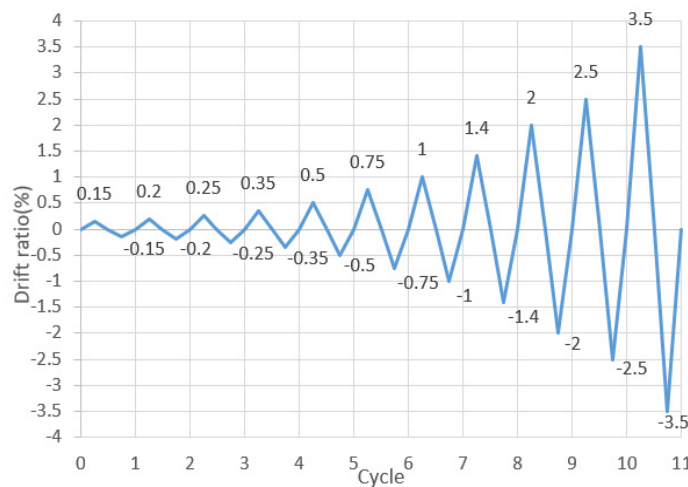
Figure 5: Drift ratio incremental loading

In this study, however, vertically cyclic loading was applied at the beam end under the drift ratio control (Figure 5), as shown in Figure 4(b). Hinge supports were arranged at the top and bottom of the columns. Hence, based on the frame deformation configuration, the lateral displacement controlled at the column end (ΔH in Figure 4(b)) was converted to the vertical displacement at the beam end for the loading increment. In addition, the applied lateral load (P in Figure 4(a)) was obtained considering the force equilibrium of the test frame system with the applied force (F in Figure 4(b)), as seen in equation (2). It is noted that there was no compressive load applied at the column of the specimens as the low-rise building is subjected to a small magnitude of the axial load. In addition, the strength of the beam-column joint is less compared with the column having a certain amount of compressive load leading to a conservation study for the joint strengthening.

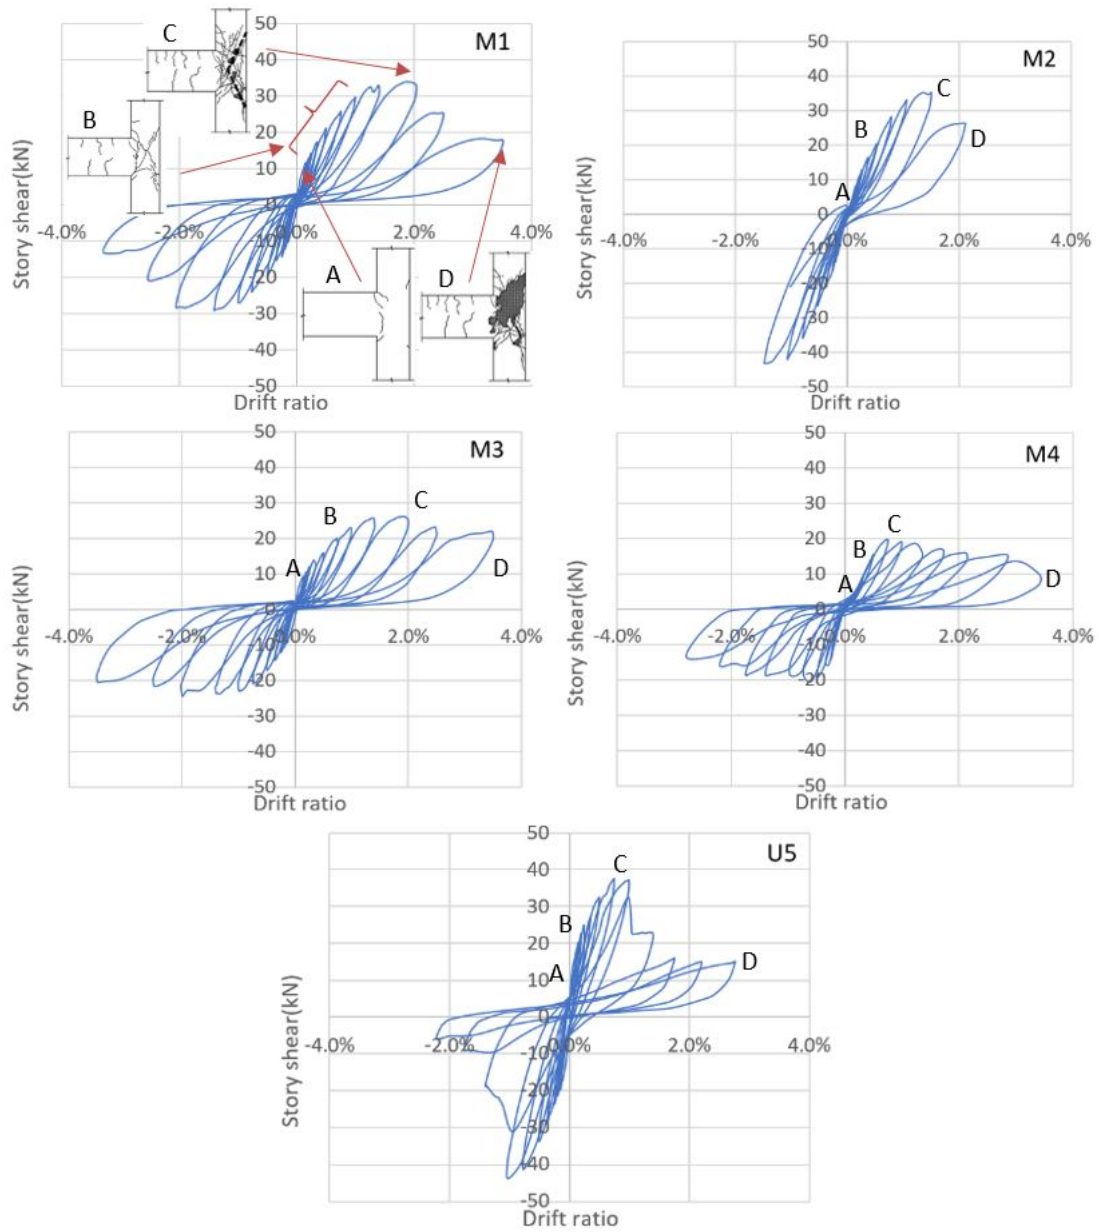
Figure 6: The relationships between story shear – drift ratio

The relationship between the story shear (P) and the drift ratio (θ) of the specimens are shown in Figure 6. The cracking and the hysteresis behavior of all specimens were similar. For the sake of the explanation, the cracking propagation of M1 specimen is shown with the hysteresis curve (the first graph of Figure 6). At the early loading with the drift ratio less than 0.2%, the stiffness was maintained constant. Then, the first flexural crack at the beam end near the column face was occurred leading to the reduction of the stiffness (Point "A"). With the increase of the drift ratio, the flexural crack was lengthened and widened. New flexural cracks in the beam were generated at sections far from the column face. Diagonal cracks in the beam-column joint also were found. However, for M4 and U5 specimens, there were only a few cracks in the beam. After the occurrence of the diagonal cracks in the beam-column joint, the further increased of the drift ratio increased the damage at the joint area, deteriorated the stiffness. The area under the relationship was decreased and the pinching effect was obviously demonstrated (Loading range "B"). The peak story shears were obtained at about the drift ratio of 1.4% with the formation of the wedge formed crack at the joint (Point "C"). With the further increase of the drift ration, the generated cracks were widened and concrete spalling was observed (Point "D"). For U5 specimen, shear crack at the bottom column was found at the section next to the externally attached steel box. Figure 7 shows the crack pattern of U5 specimen. Figure 8 shows the crack development of all specimens. Hence, as the failure mode was brittle, the energy dissipation capacity of the specimens was quite limited. The failure mode of M1-M4 specimens was the beam-column joint failure. However, it is noted that M2 specimen test was stopped accidentally at the post peak loading due to the improperly loading alignment.

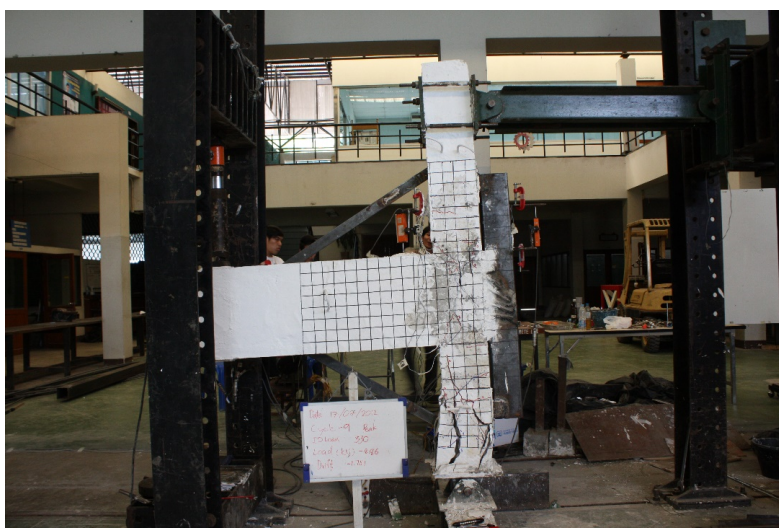
Figure 7: Failure of U5 specimen

- Considering M4 specimen with the very small column compared with the connecting beam, the column was failed at a very low story shear. As the joint area is also very small, the column failure was immediately followed by the joint shear failure. There were no damages in the connecting beam. Hence, the externally attached steel column the exterior was introduced in U5 specimen. The result of the installation increased the story shear from 18.6 kN of M4 specimen to 37.5 kN of U5 specimen which is 2.02 times higher. However, the ductility is needed to be improved as the failure of U5 specimen was the column failure.

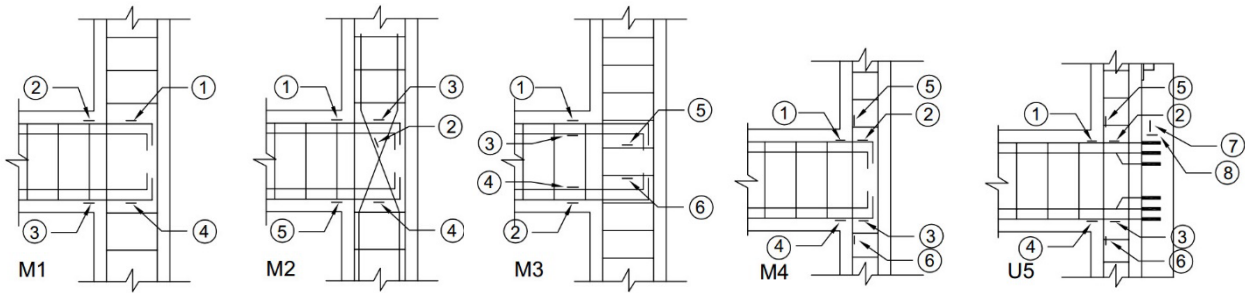
Figure 9: Strain gauge positions

Strain gauges were attached to the reinforcement at the expected critical sections as shown in Figure 9. Some strain values obtained during the tests are shown in Figure 10. The strains in the longitudinal beam reinforcement at the column face are smaller than the yield strains shown in Table 1. The strain the joint shear reinforcement (M3-STG6) is also small. Hence, the contribution of the shear reinforcement to resist the joint shear force is negligible.

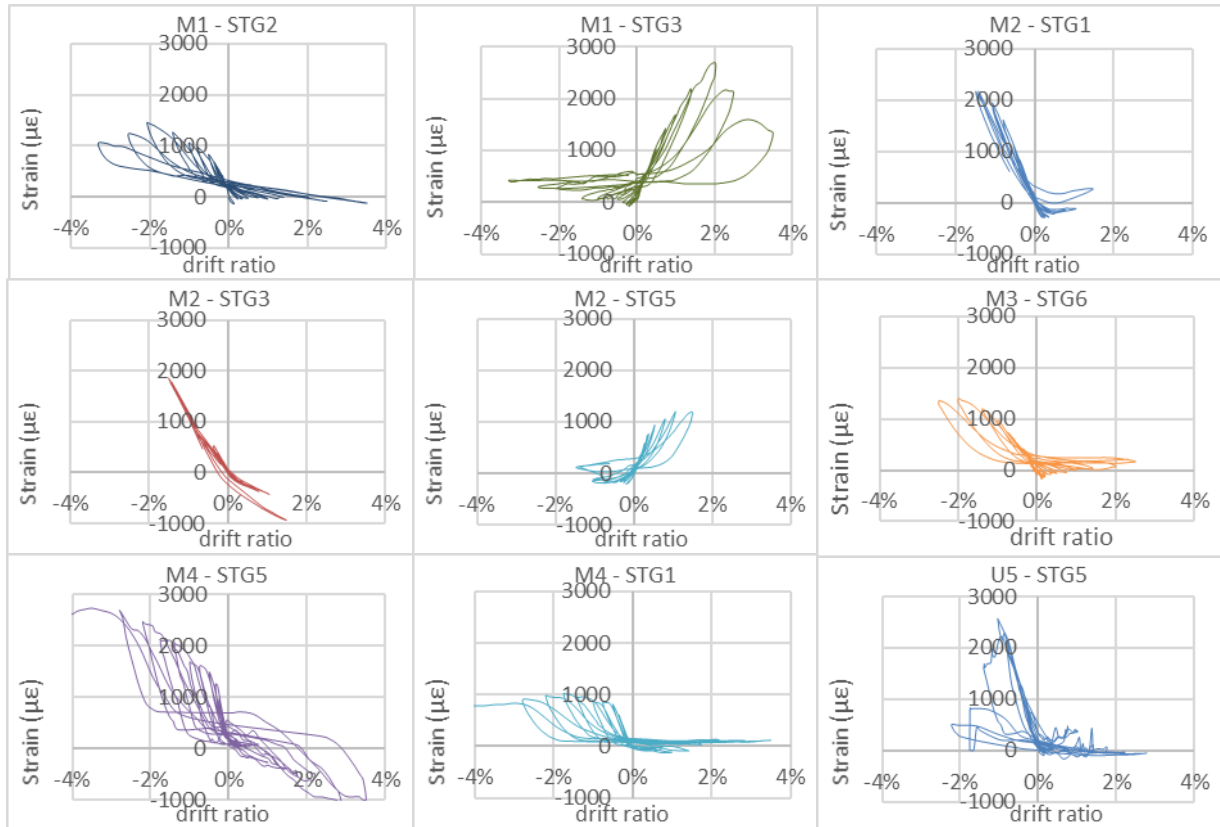
Figure 10: Strain in the reinforcement

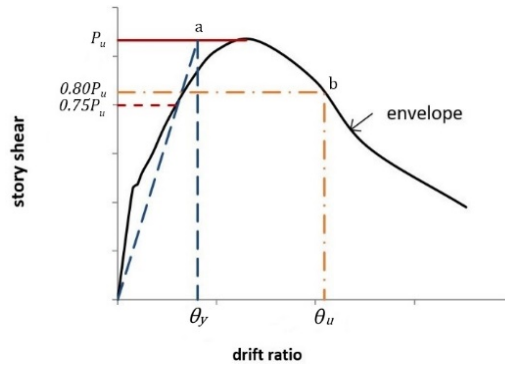
Figure 11: Determination of ductility (Legeron & Paultre, 2000)

Based on the research of Legeron & Paultre (2000), the yield drift ratio and the ultimate drift ratio can be defined, as shown in Figure 11. First, the 0.75 of the ultimate story shear ($0.75 P_u$) is determined and a line from the origin to the $0.75 P_u$ story shear to meet the ultimate story shear at point “a” is drawn. Then, the yield drift ratio can be defined corresponding to the point “a”. For the ultimate drift ratio, it is defined as the drift ratio at the after peak story shear of $0.80 P_u$ (point “b”). The envelop curves of the specimens are shown in Figure 12. Considering the smaller loading capacity

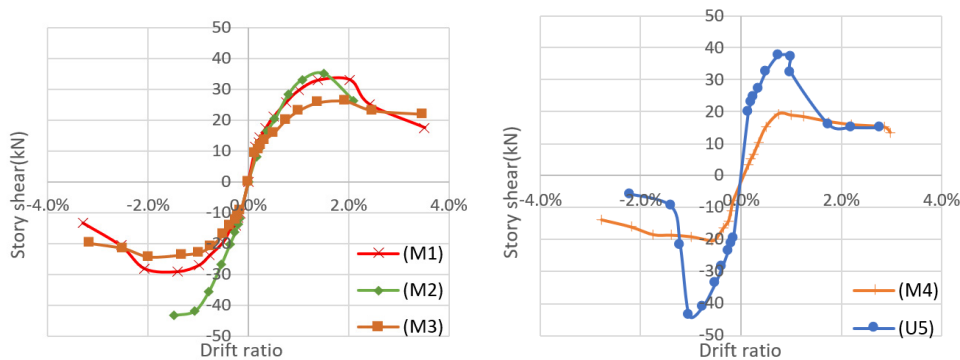
Figure 12: Envelop curve of specimens M1 - U5

between the push and pull sides, the story shear capacities of the specimens are shown in Table 3. The story shear of M1, M2 and M3 specimens were 29.0 kN, 35.0 kN and 24.4 kN., respectively. For M4 specimen, the story shear capacity was only 18.6 kN. The upgraded U5 specimen possessed the story shear capacity of 37.5 kN which is 2.02 times of the strength of M4 specimen. The comparison ratio of the ultimate story shear between the test and calculation are in the range of 0.64-1.42. The calculation is overestimated for the first group of specimens (M1-M3) and underestimated for the small column specimens (M5 and U5). The smaller ductility of the push and pull sides are shown in Table 3. As all the specimens were failed by the brittle failure modes, the ductility of the specimens is quite small values (2.02-4.54).
