## Study of Structural Capacity and Serviceability affecting the obstruction of Residential Door

### Abstract

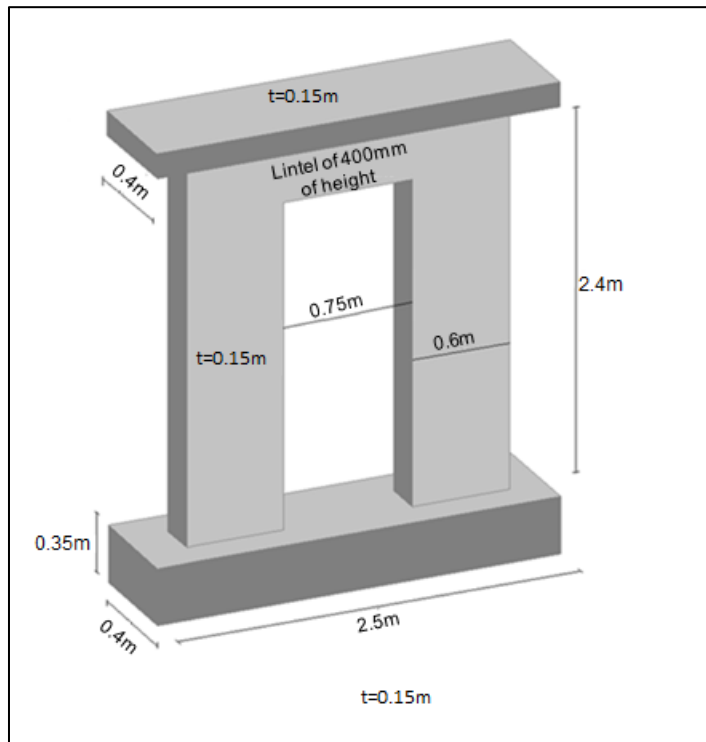
According to the technical inspections made to the main buildings of Concepcion city and surrounding areas, it was possible to establish a standard frame, according to the three criteria above-described. It was decided to select the configuration corresponding to entrances of apartments located at the end of corridors (Figure 5), which means entrances formed by slender walls or columns of 60 centimeters width, making up the structural frame of the door. The lintels considered an average height of 40 centimeters, for 2.4 meters inter-stories.

Figure 5 Structural system according to field study.

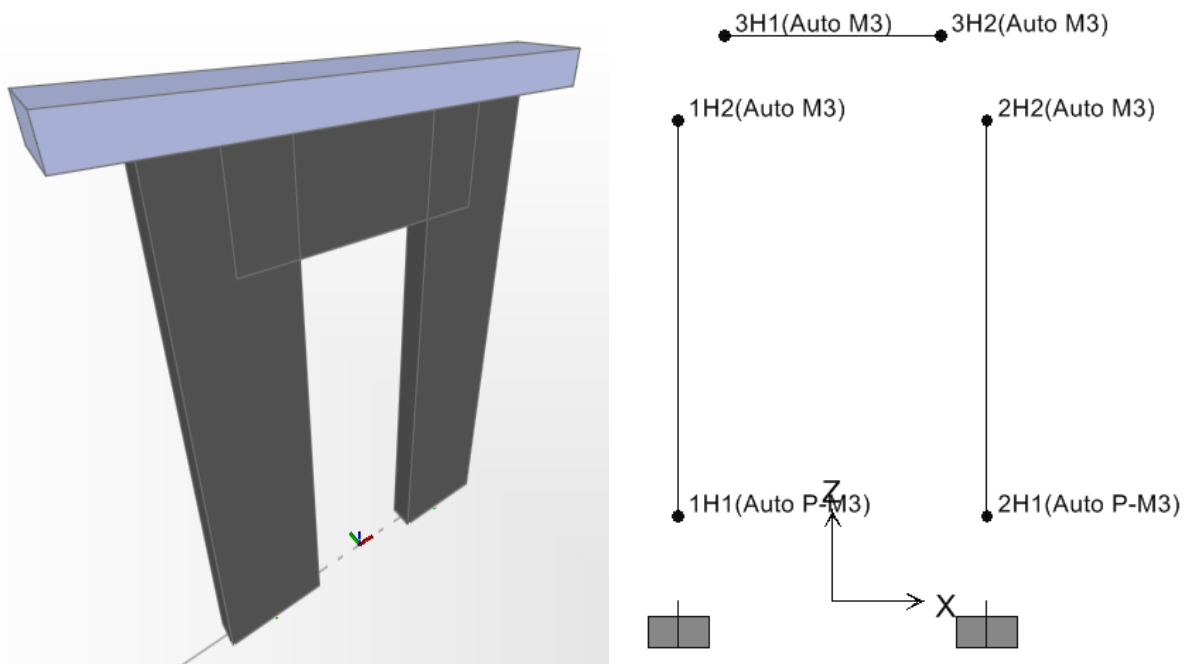
Figure 8 Analytical model representing the studied framework.

- The theoretical capacity curve of the framework was obtained from an analytical model of six equivalent bars, where the non-linearity of the materials was incorporated by means of six plastic hinges located at the ends of the bars (Figure 8).

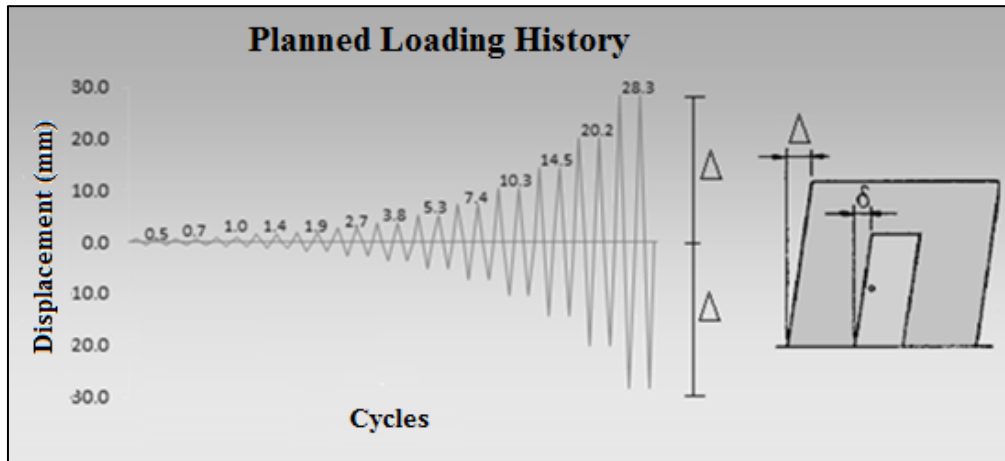
Figure 10 Protocol of planned displacements according to FEMA 461.

One of the main protocols that are required for proper performance and interpretation of quasi-static tests is the monitoring of the history of displacements applied to systems, whose emphasis is on the development of progressive displacements in time, for proper analysis and record of deformations, cracks and lateral distortions of the door in study. Therefore, the protocol used corresponds to that stated by FEMA 461 (Figure 10), for reinforced concrete elements, which follows a geometric progression of ratio 1.4 within a range of 0.5 to 28.3mm.

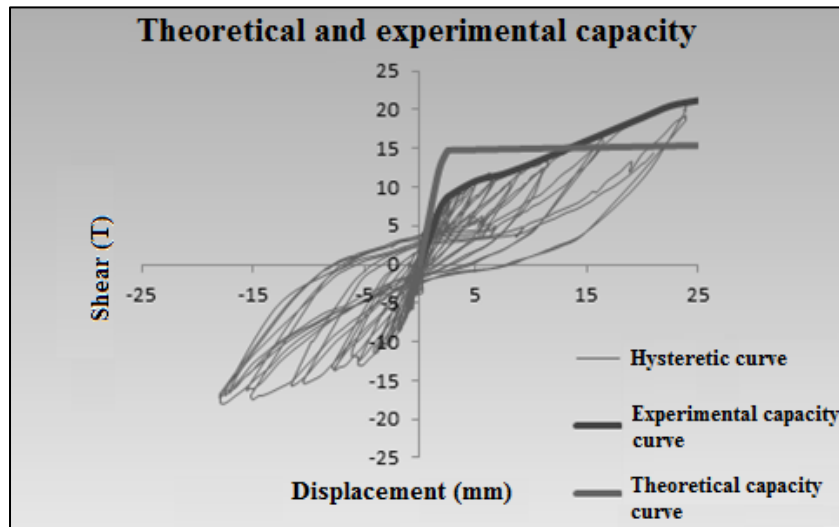
Figure 11 Structural Capacity of the theoretical Pushover model versus the Experimental Capacity.

The structural capacity reached by the study system is shown in Figure 11 (Experimental Capacity Curve), in contrast to the theoretical capacity obtained by the theoretical "Pushover" method (Theoretical Capacity Curve). The hysteresis curve obtained shows a symmetric behavior

However, the structural capacity of the theoretical “Pushover” model obtained by systems of plastic hinges, shows differences in ductility within the elastic and plastic phases. By way of example, while both methods begin their non-linear range for the same level of displacement (2.5mm of relative distortion), the experimental test does it for a load 30% lower.

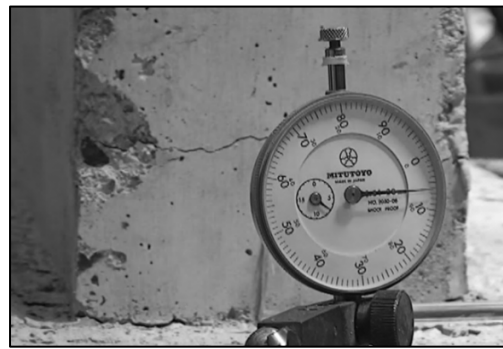
Figure 13 Cracking at the bottom.

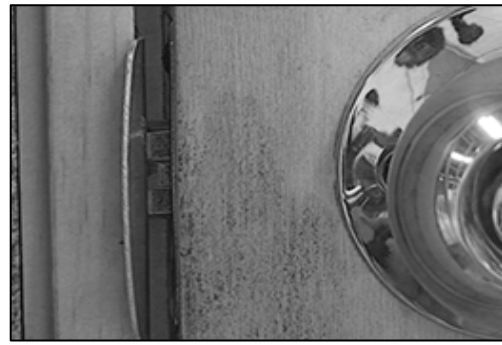
Figure 15 Distortions in the lock.

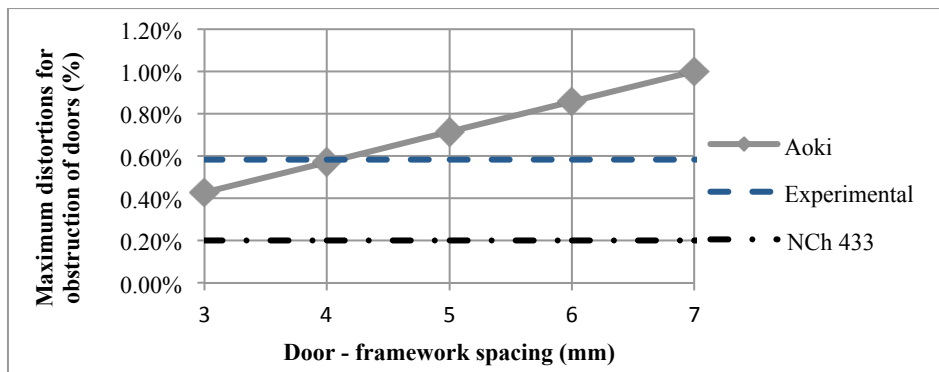
Figure 16 Comparison of maximum distortions for obstruction of doors (70cm wide), among: Aoki (1984) criteria; Chilean standard NCh433 and; Experimental values of the current study.

Figure 16 shows a comparison among: (1) the serviceability criteria for doors specified by Aoki (1984); (2) those given by the Chilean standard NCh433 and; (3) the values found experimentally in this study for doors of 70cm wide.

As seen in Figure 16, the distortions found experimentally were close to those proposed by Aoki (1984), for a 4mm framework spacing. On the other hand, it is observed that the requirements of Chilean standard NCh433 are conservative in comparison with the experimental evidence and the proposal values of Aoki (1984). Also, it is important to emphasize that the steel reinforcement of the structural framework tested was detailed according to the seismic frame requirements defined by the ACI 318 standard code. Based on this fact, it could be hypothesized that if the steel reinforcement of the structural framework is less demanding, it is probable to obtain similar values of maximum distortion for the three serviceability criteria for doors.

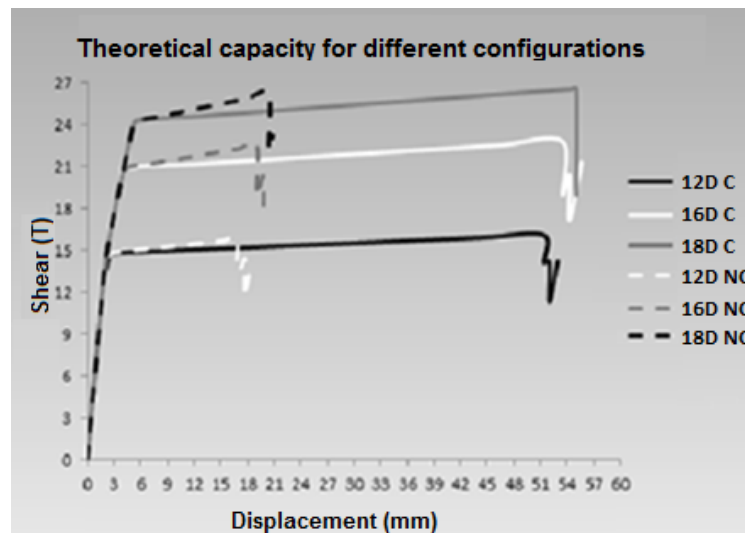
Figure 17 Theoretical capacity for different steel configurations.

It follows from the results obtained by the Software SAP2000, the importance of the confinement for developing of the capacity, in terms of displacement levels. Approximately, for a 20mm distortion, the non-confined structural elements (12D NC, 16D NC and 18D NC) can easily reach the failure zone after having experienced a very similar behavior in their early stages. Note that, the quality of material, geometry and reinforcement of the lintel, were the same for each configuration. Although the theoretical capacity analysis of the main system of study evidenced some variations with respect to the experimental test, it was possible to identify that for these 6 additional configurations, unconfined models (modeled with pre-defined plastic hinges without shear), only admit deformations equivalent to 30% of their counterparts confined, where these confined models reached the rupture zone at displacements close to the 50-60mm. As the main result of the use of non-contained elements, it was found that early rupture of the concrete would allow detachment of material during a seismic event, provoking deflections and lateral distortions of the door frames for displacements much lower than those experienced by elements confined properly.
