Experimental Characterization of the Fatigue Life of Bolted Flange Connections in Wind Turbine Towers: Implications for Structural Integrity

Abstract

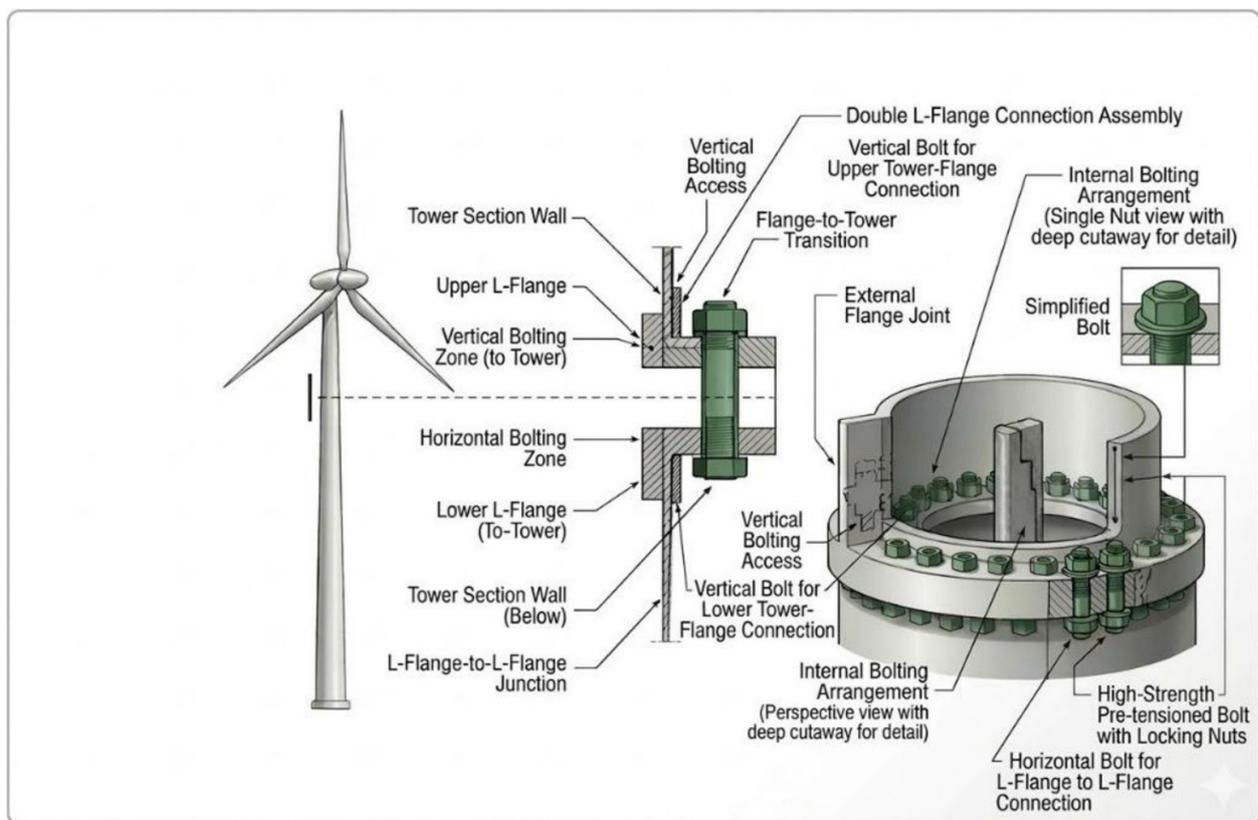
Figure 1 Location of bolted flange connections in a typical wind turbine tower and detail of the investigated connection geometry.

Figure 1 illustrates the structural context of this study, showing the location of bolted flange connections within a typical wind turbine tower and the detail of the connection geometry investigated experimentally.

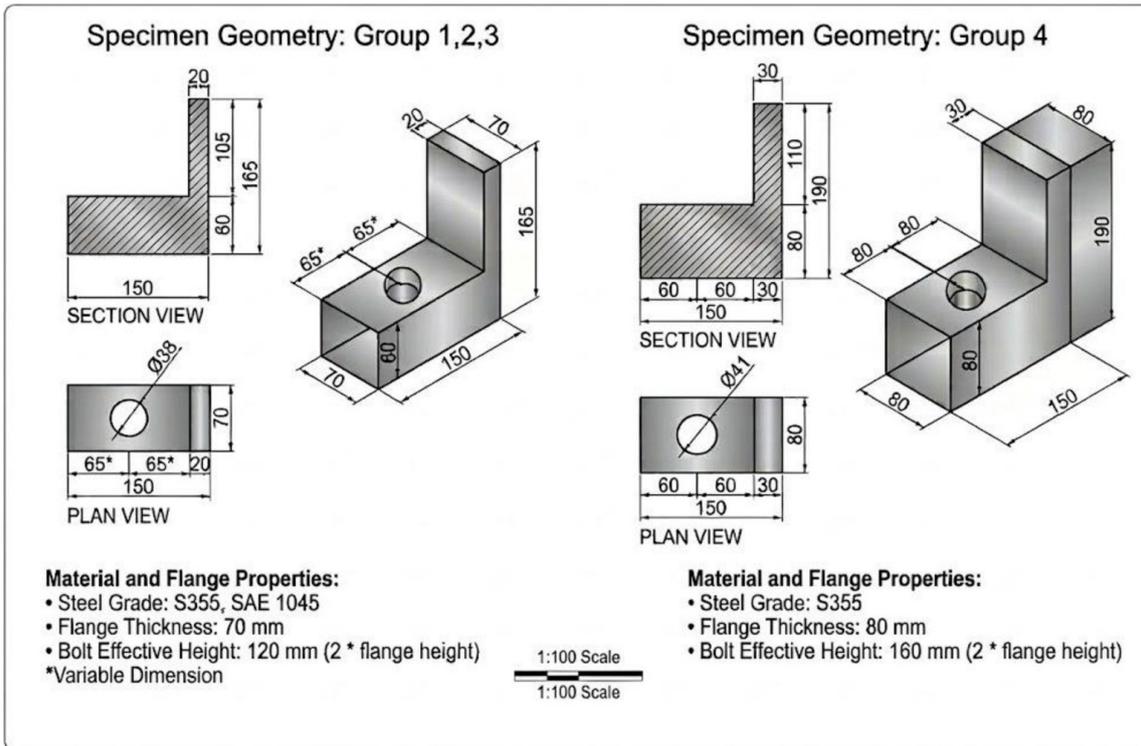
Figure 2 Technical drawing and dimensions of flange specimens.

The L-shaped configuration enables pure tensile loading on the fastener while maintaining representative flange bending stiffness. Flange thickness was selected to prevent flange failure prior to bolt failure under design loads.

The test configuration was designed to apply predominantly axial tensile loading to the bolt, consistent with the dominant load transfer mechanism in wind turbine tower flange connections. In ring flange connections, the primary bolt loading arises from axial forces and bending moments acting on the tower cross-section, which are transferred to the bolts as tensile forces. Shear forces acting parallel to the flange interface are resisted by friction between the contact surfaces and do not directly load the bolts in shear under normal operating conditions (Van-Long et al., 2013; Seidel and Schaumann, 2021). Consequently, shear effects on bolt fatigue are considered negligible in the present configuration, and the axial tensile loading applied in this study represents the critical design loading condition. Figure 2 presents the technical drawing and Figure 3 shows manufactured specimens.

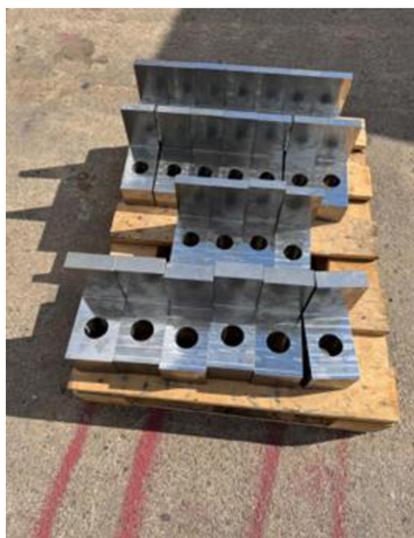
Figure 3 Manufactured flange specimens.

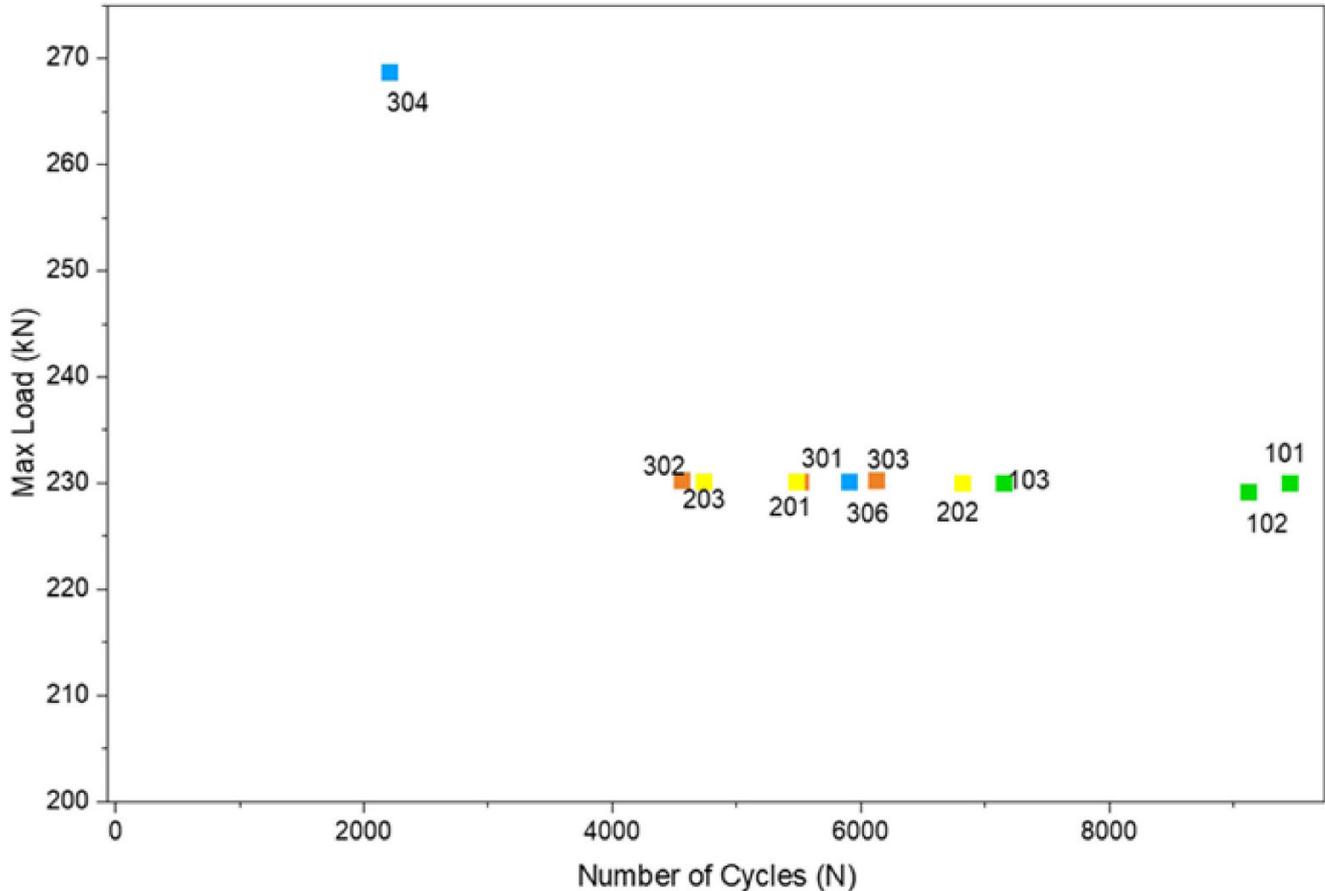
Figure 4 Fatigue life comparison graph.

M36 baseline S355 (Group 3): 5,916 cycles (single specimen)

M36 SAE 1045 (Group 1): $5,395 \pm 791$ cycles

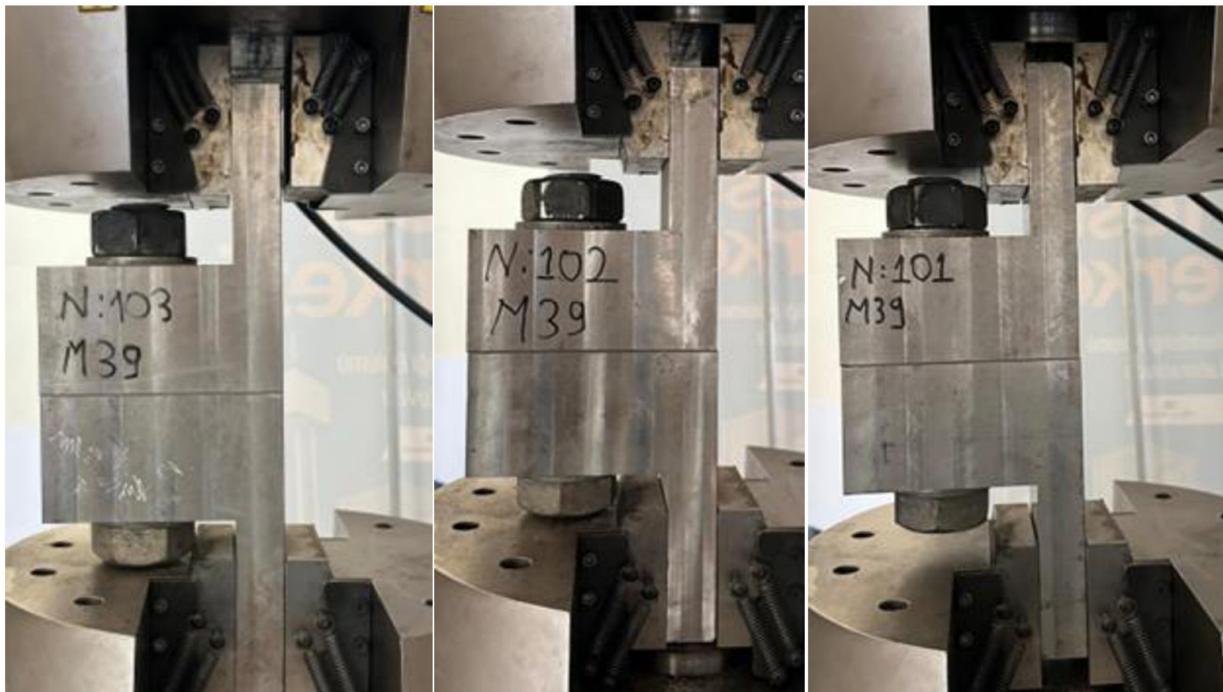
Figure 5 Pre-fatigue test appearance of N101, N102, N103 specimens with M39 bolts.

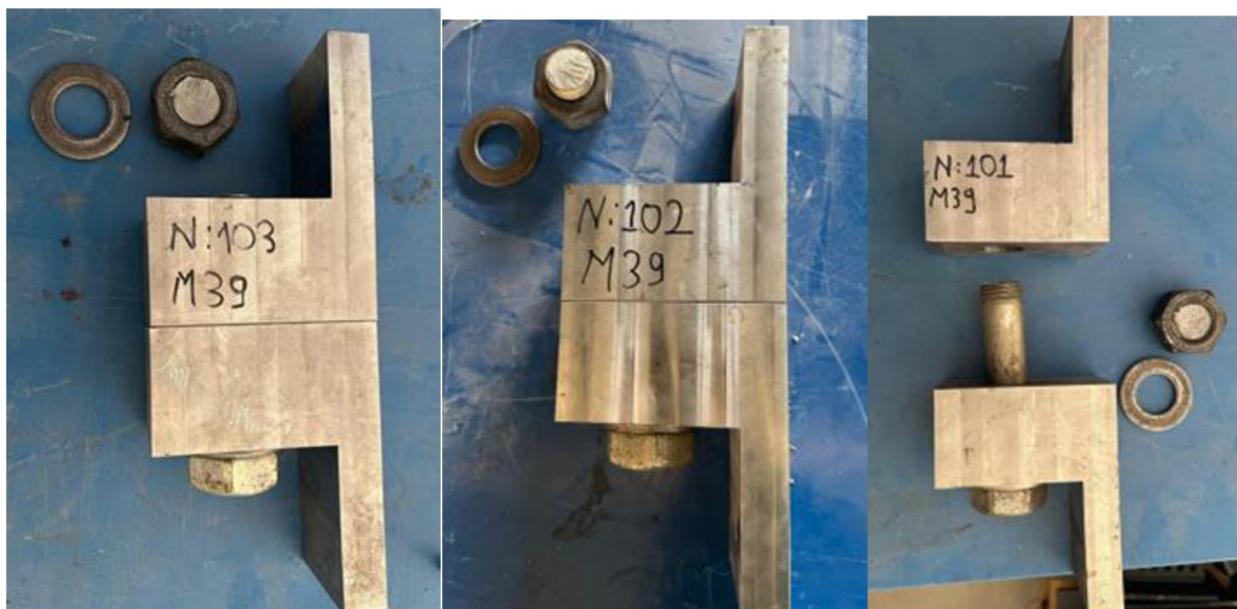
Figure 6 Post-fatigue test appearance of N101, N102, N103 specimens with M39 bolts.

All M39 specimens exhibited classic bolt shank fatigue fracture with crack initiation at thread root region, progressive crack growth evidenced by beach marks, and final rapid fracture zone occupying 30-40% of cross-section. No thread stripping or nut damage was observed.

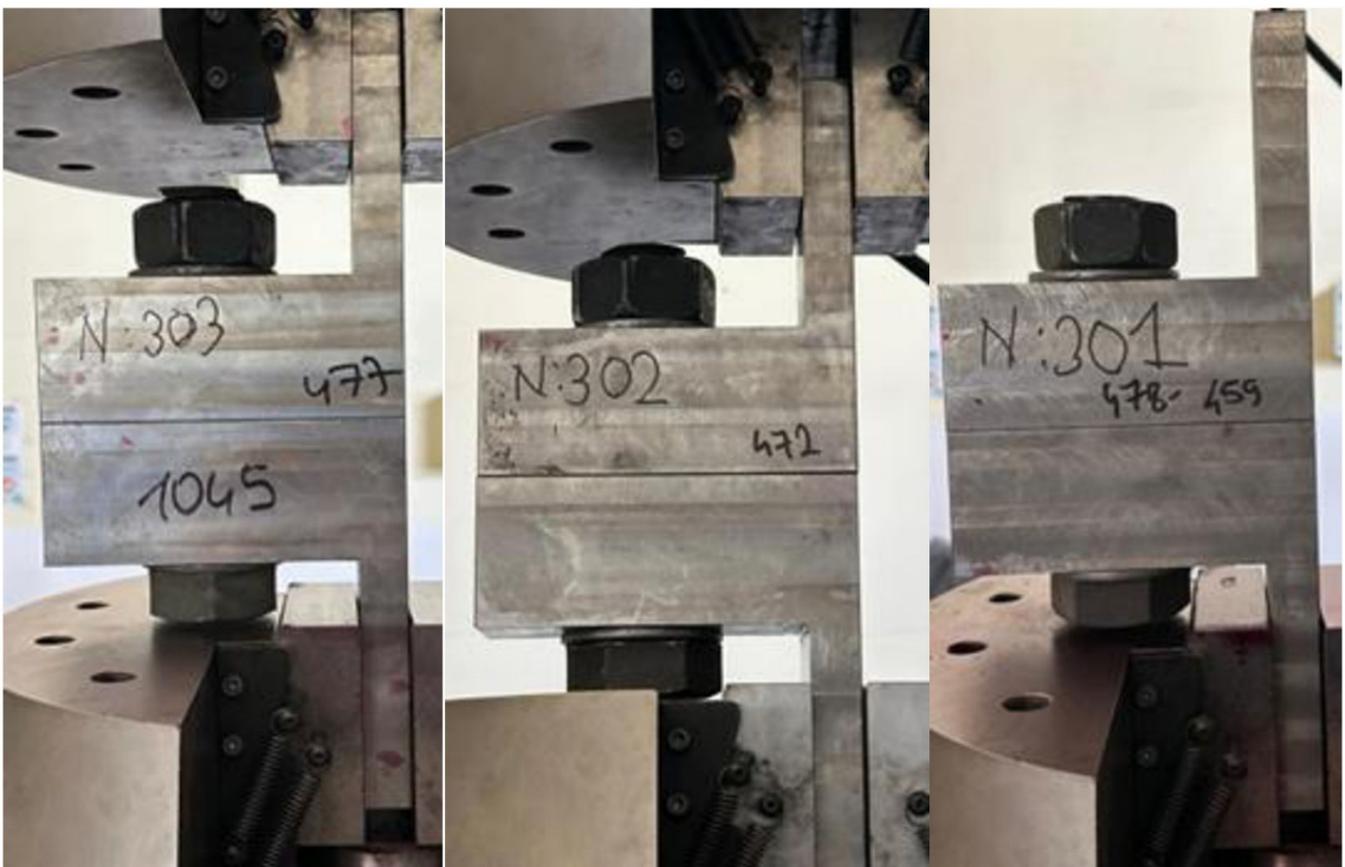
Figure 7 Pre-fatigue test appearance of N301, N302, N303 specimens.

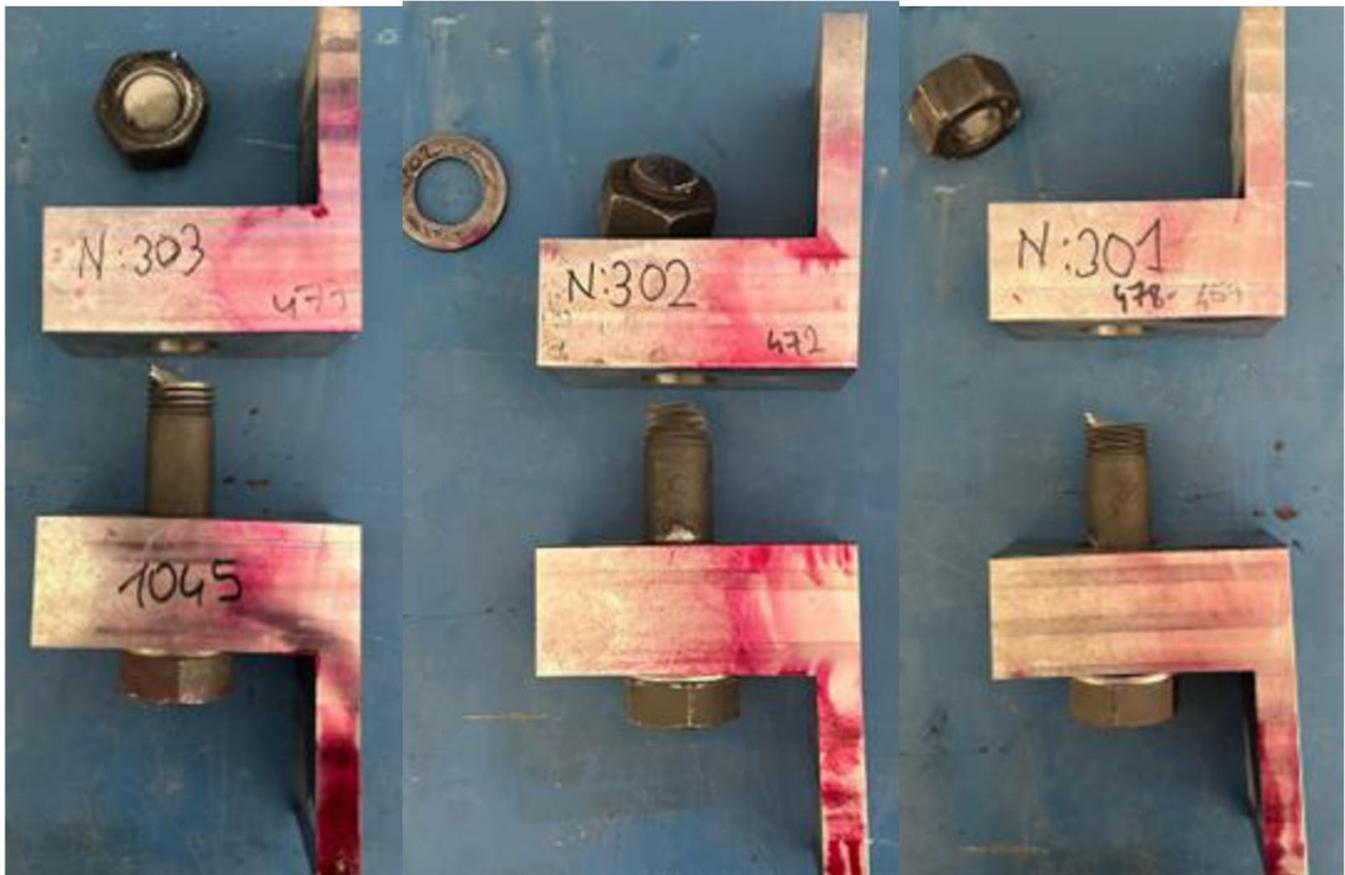
Figure 8 Post-fatigue test appearance of N301, N302, N303 specimens.

SAE 1045 carbon steel (high strength, low ductility) exhibited characteristic brittle fracture behavior with sharp, clean fracture surfaces showing minimal plastic deformation, limited flange bending with elastic-dominated response, and multiple sharp radial cracks propagating from bolt holes with minimal crack tip blunting. The 7-9% elongation capacity (Isik and Alemdar, 2025) resulted in limited energy dissipation prior to final fracture, consistent with brittle failure modes observed in high-strength, low-ductility steels under cyclic loading (Grimsmo et al., 2016; Plaitano et al., 2022).

In contrast, S355 structural steel (moderate strength, high ductility) displayed ductile fracture characteristics including more diffuse fracture surfaces with evidence of substantial plastic deformation, noticeable flange bending and yielding concentrated near the bolt hole region, and fewer but wider cracks with visible plastic zone development around crack tips. The superior 18-19% elongation capacity (Isik and Alemdar, 2025) enabled progressive damage accumulation with visible warning signs, consistent with ductile fracture behavior documented for structural steels (Johansen and Waldeland, 2016; Alonso-Martinez et al., 2018).

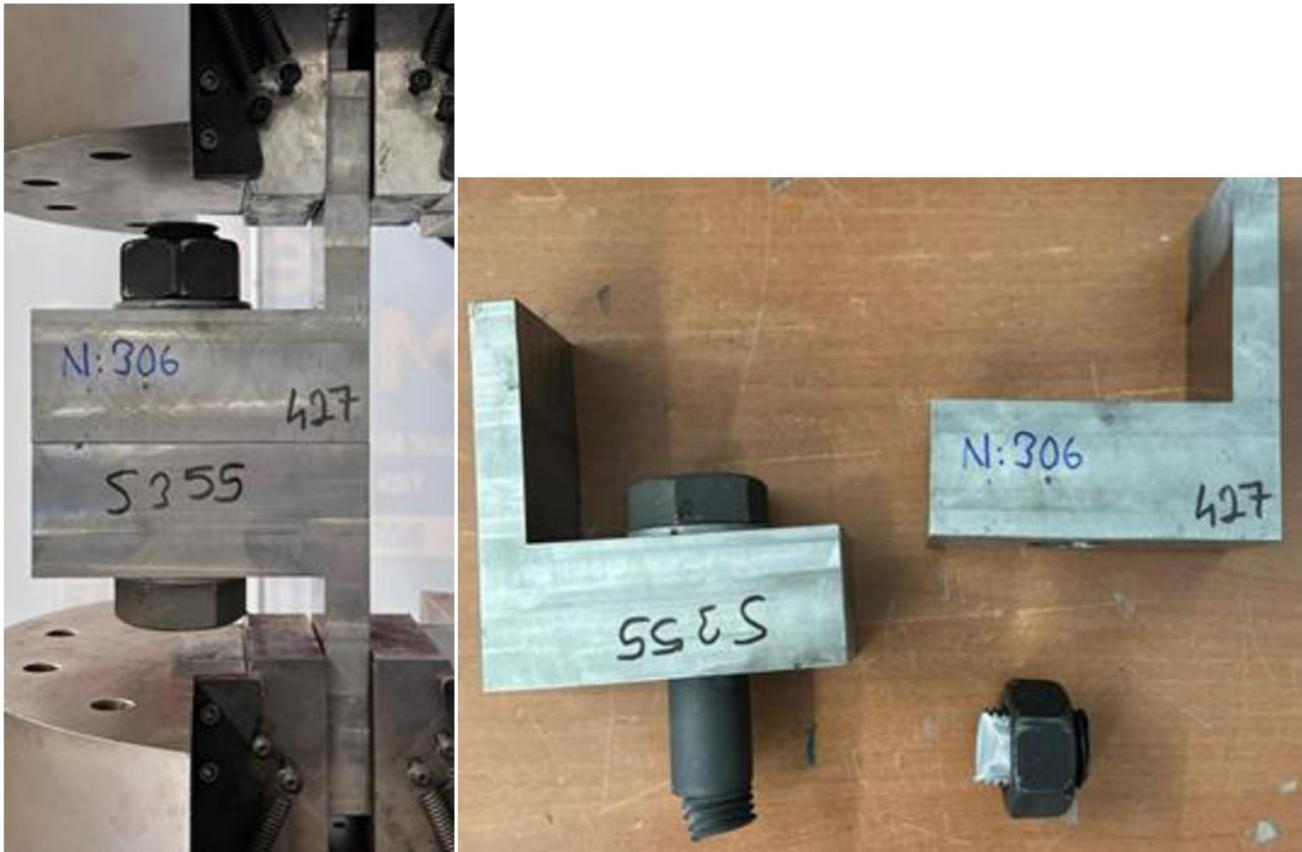
Figure 9 Pre and Post fatigue test appearance of N306 specimens.

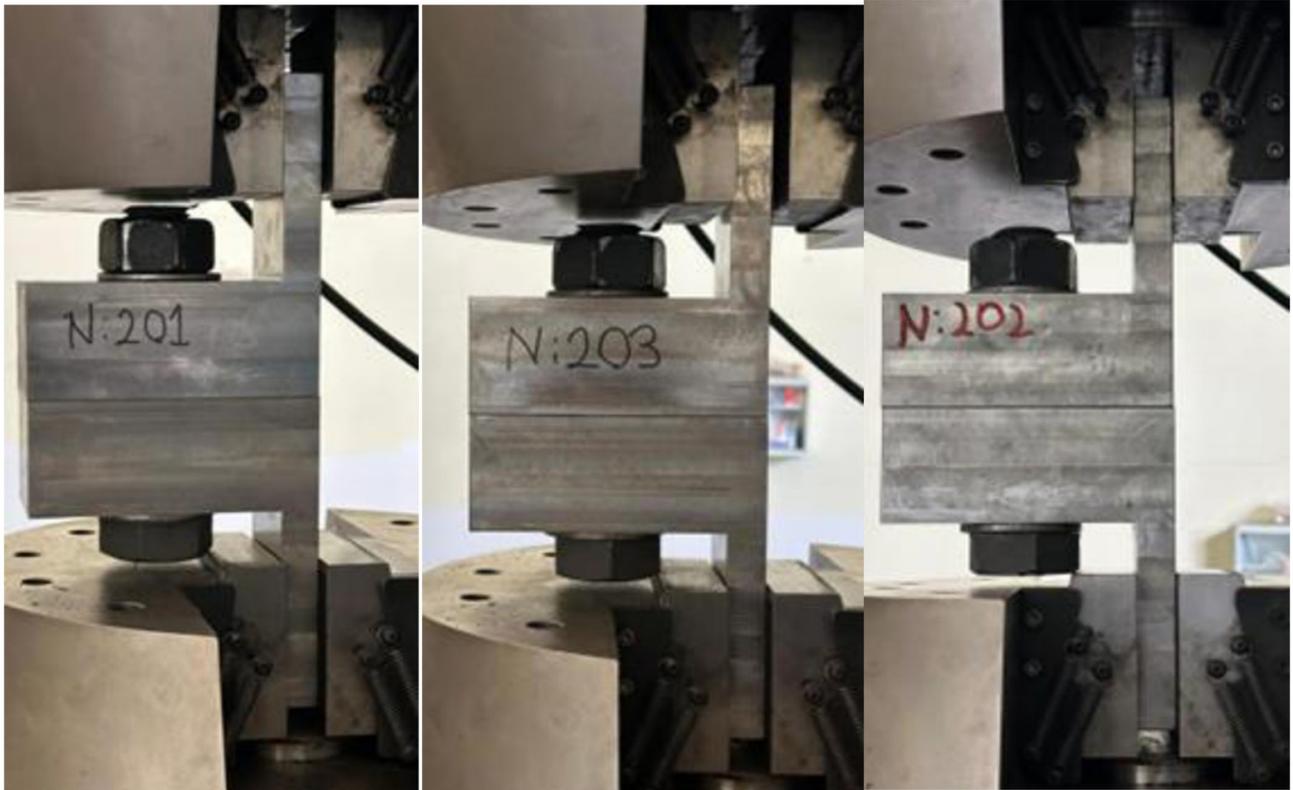
Figure 10 Pre-fatigue test appearance of N201, N202, N203 specimens.

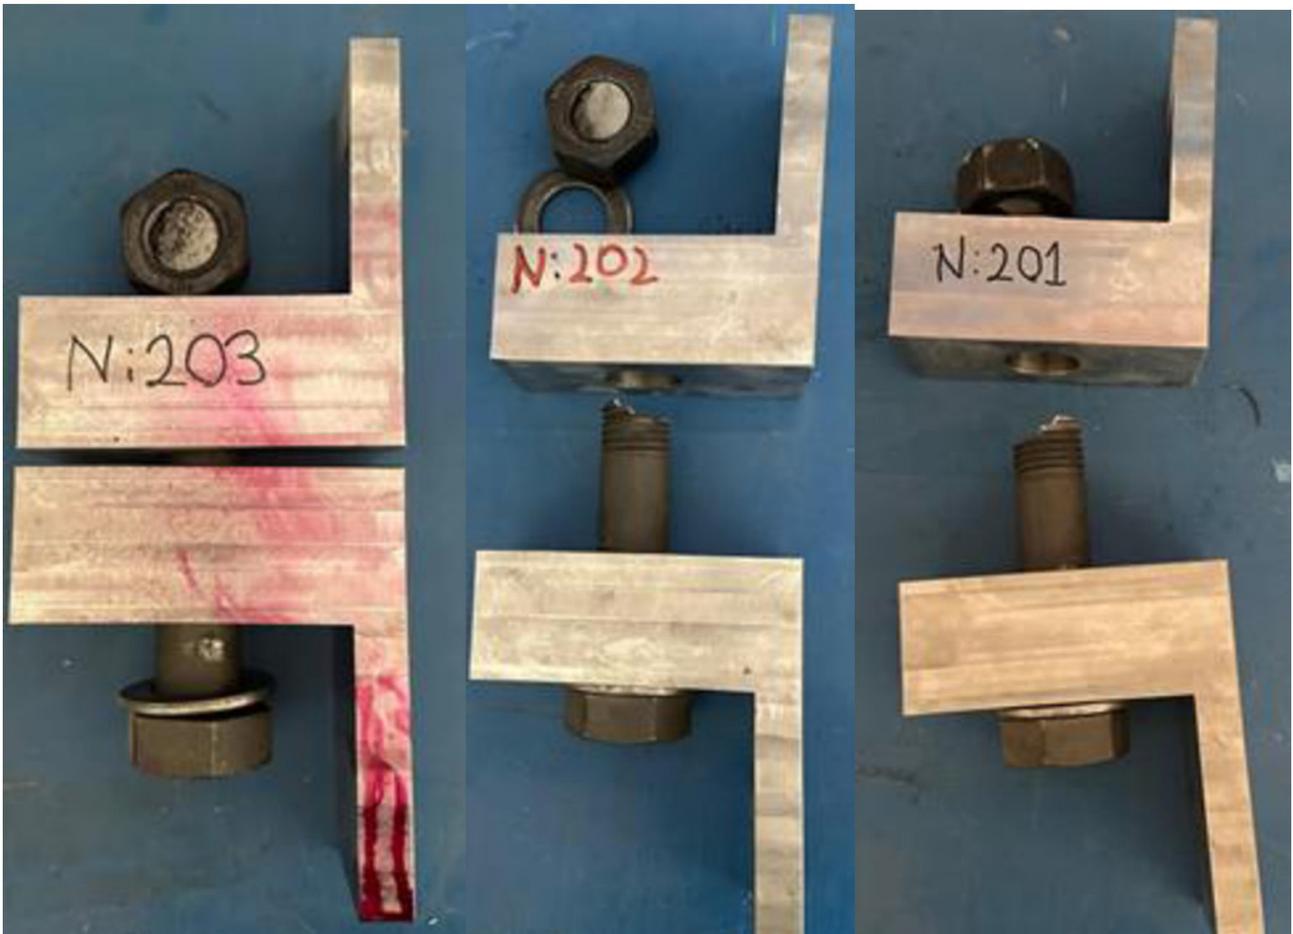
Figure 11 Post-fatigue test appearance of N201, N202, N203 specimens.

Unlike centric tests where all specimens exhibited pure bolt fracture, eccentric loading produced mixed failure modes. Specimen N:201 showed combined flange and bolt failure, N:202 exhibited bolt shank fracture only, while N:203 shown combined failure with severe local flange buckling. Pre- and post-test appearances Figures 18-19 clearly illustrate these contrasting damage patterns.

Eccentric loading induced additional flange damage mechanisms including local yielding and indentation around bolt hole bearing surface, out-of-plane bending causing measurable flange curvature 3-10 mm deflection, and secondary crack networks in flange material emanating from highly stressed regions. These observations indicate that eccentric loading fundamentally alters the system-level load path and introduces failure modes extending beyond simple bolt fatigue.

Eccentric loading produced combined bolt-flange failure in specimens N:201 and N:203, characterized by local yielding around bolt hole bearing surface, out-of-plane flange bending (3–10 mm deflection), and severe local buckling in N:203. This altered failure mode under eccentric loading conditions confirms the significant influence of load path irregularities on system-level connection behavior, consistent with findings by Van-Long et al. (2013) and Seidel and Schaumann (2021) on the importance of geometric imperfections in bolted flange connections.

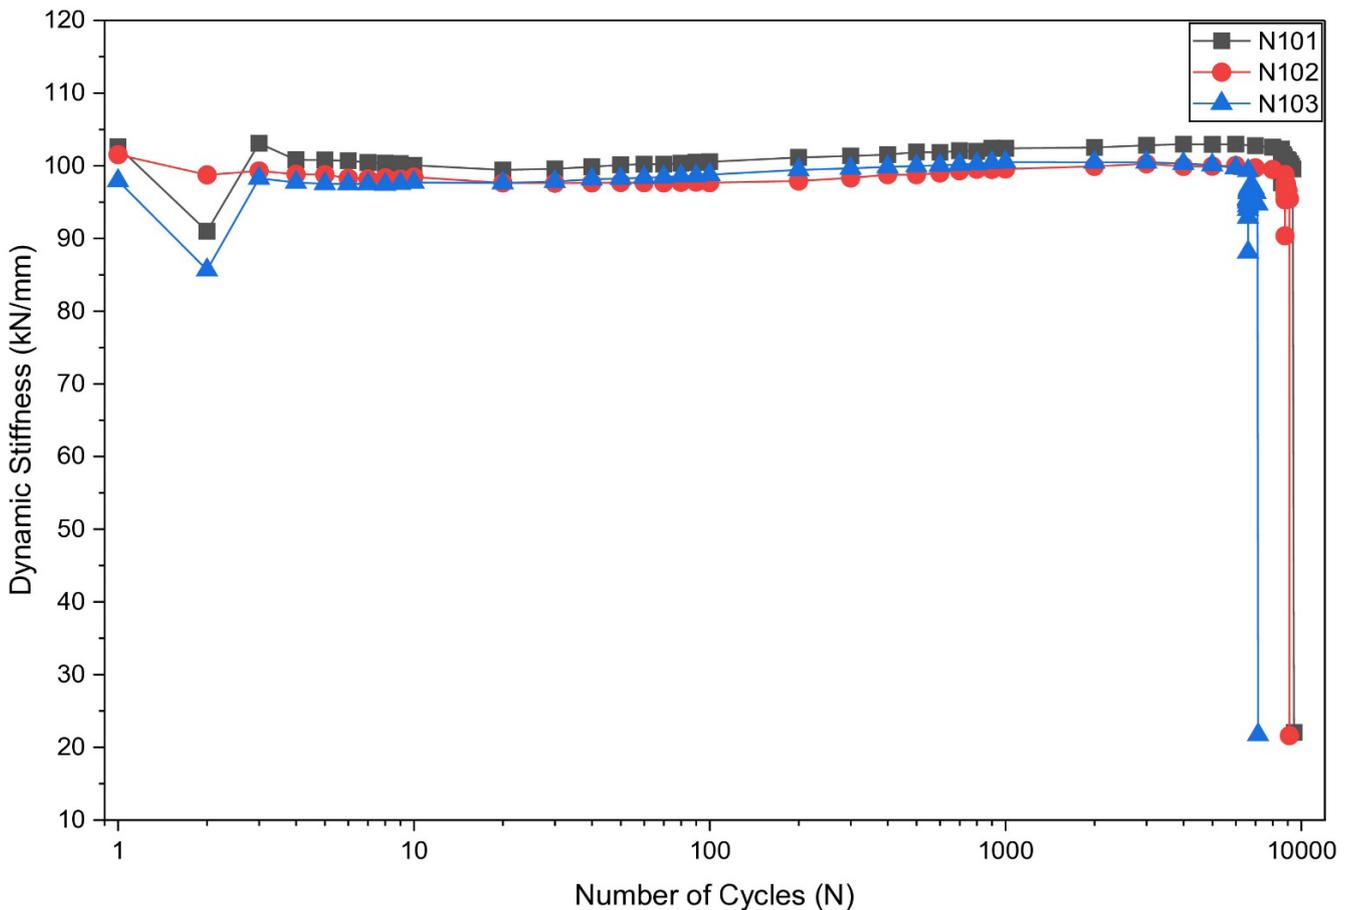
Figure 12 Dynamic stiffness vs. cycle count for N101, N102, N103 (M39 bolts).

The degradation process begins with an extended initial stable period occupying approximately 0-80% of total fatigue life, during which connection stiffness remains relatively constant with less than 5% reduction from initial values. This phase represents the crack incubation period where microscopic damage accumulates at the atomic scale through dislocation motion and microcrack formation at stress concentrators, particularly in the thread root region (Zhou et al. (2022a); Yang and Lei, 2017). The minimal detectable stiffness change during this phase reflects that damage remains highly localized and has not yet compromised the overall load-bearing cross-section of the bolt.

As damage progresses into the second phase (80-95% of life), a transition occurs from microscopic to macroscopic crack development. Stiffness begins gradual but measurable degradation at a rate of 0.5-1.0% per 1,000 cycles, with total reduction reaching 5-15% by the end of this phase. This period corresponds to stable crack growth under Mode I tensile opening, where the crack front advances incrementally with each loading cycle. The crack growth rate follows Paris law behavior (11) with the stress intensity factor range governing propagation velocity (Ni et al., 2024; Schaumann and Eichstädt, 2015). Visual examination of fracture surfaces confirms this stable growth regime through the presence of distinct beach marks—concentric patterns indicating crack front position at various stages of life.

The final phase 95-100% of life exhibits dramatically accelerated stiffness degradation, with the remaining 5-10% stiffness loss occurring within the last 5-10% of fatigue life often just a few hundred cycles. This rapid deterioration signals unstable crack propagation as the remaining ligament area becomes insufficient to sustain applied loads, driving stress intensity toward the material’s fracture toughness. The crack growth rate increases exponentially, transitioning from controlled fatigue crack extension to rapid ductile tearing or brittle fracture depending on material ductility. Dynamic stiffness data for all test groups Figures 12, 13, 14 clearly show this characteristic degradation signature.

Comparing degradation characteristics across test groups reveals distinct stiffness evolution patterns. M39 bolts Group 4 exhibited lower total stiffness loss 18-21% compared to M36 configurations 22-29%, with more gradual degradation patterns and extended Phase 1 duration. This behavior indicates that larger bolt diameter not only provides higher absolute fatigue life but also delays crack initiation, resulting in a larger proportion of life spent in the stable low-damage regime. Conversely, eccentric loading Group 2 produced highest total stiffness loss 24-29% with more irregular degradation patterns featuring sudden drops corresponding to discrete flange yielding events. The onset of Phase 2 degradation occurred earlier approximately 75% of life compared to concentric loading 80%, reflecting the additional damage mechanisms introduced by bending moments and flange plasticity.

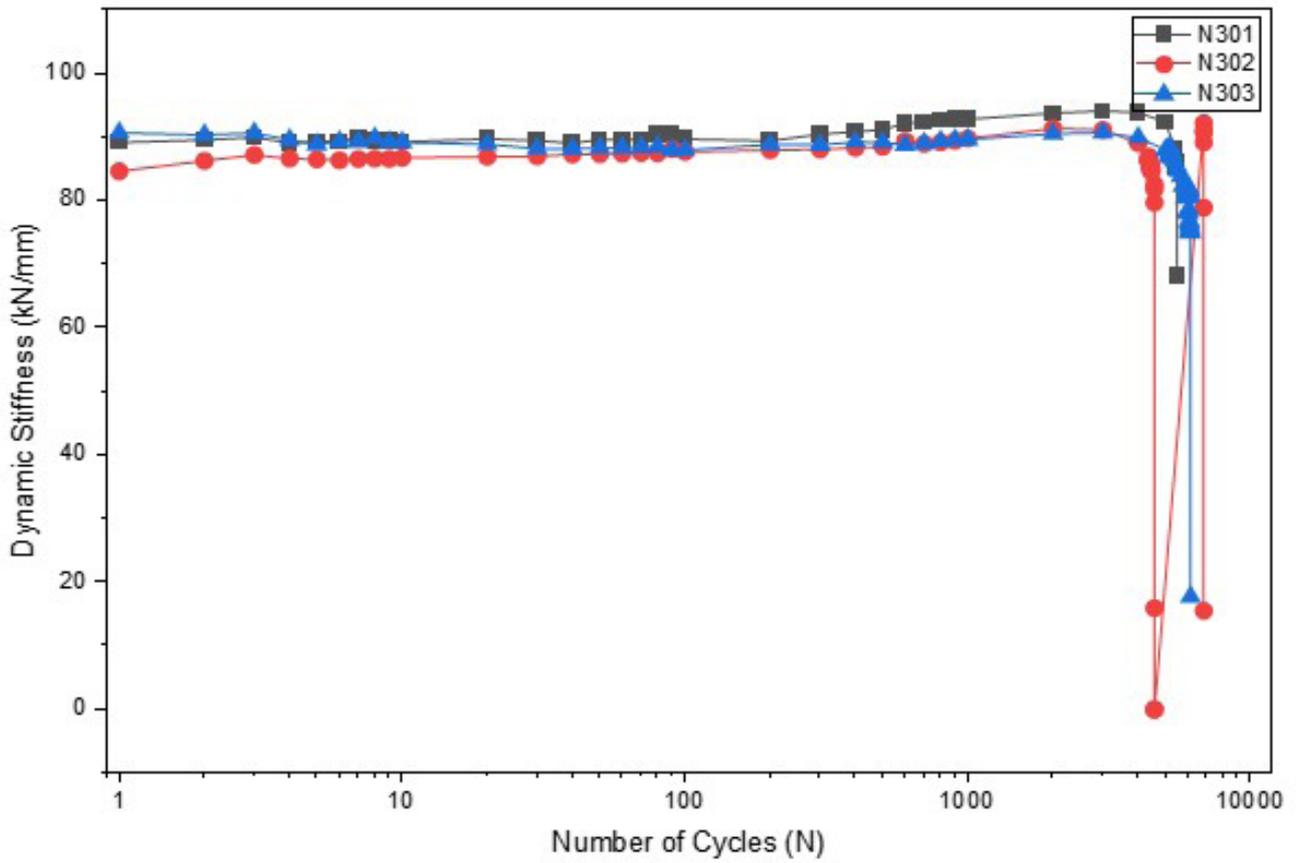
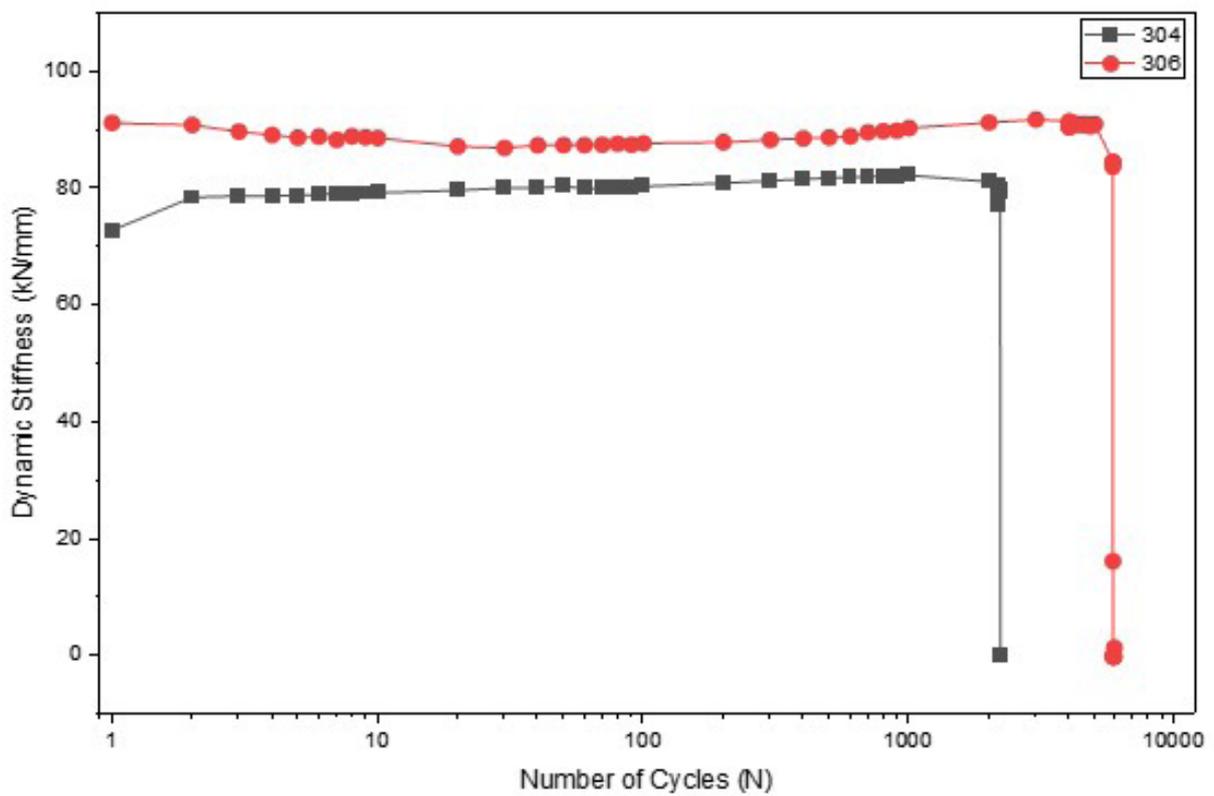
Figure 13 Dynamic stiffness vs. cycle count for Groups 1 and 3.
