# Experimental Characterization of the Fatigue Life of Bolted Flange Connections in Wind Turbine Towers: Implications for Structural Integrity

Bolted flange connections, fatigue, load eccentricity, dynamic stiffness, accelerated testing.

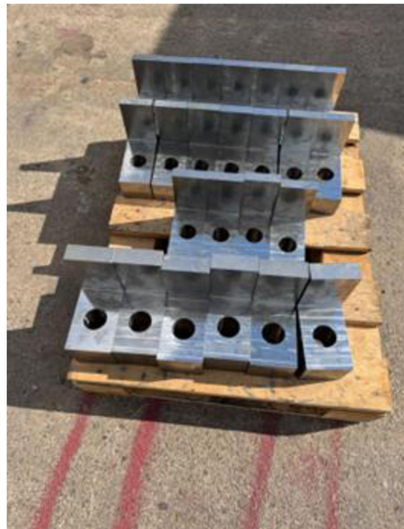
Figure 3 Manufactured flange specimens.

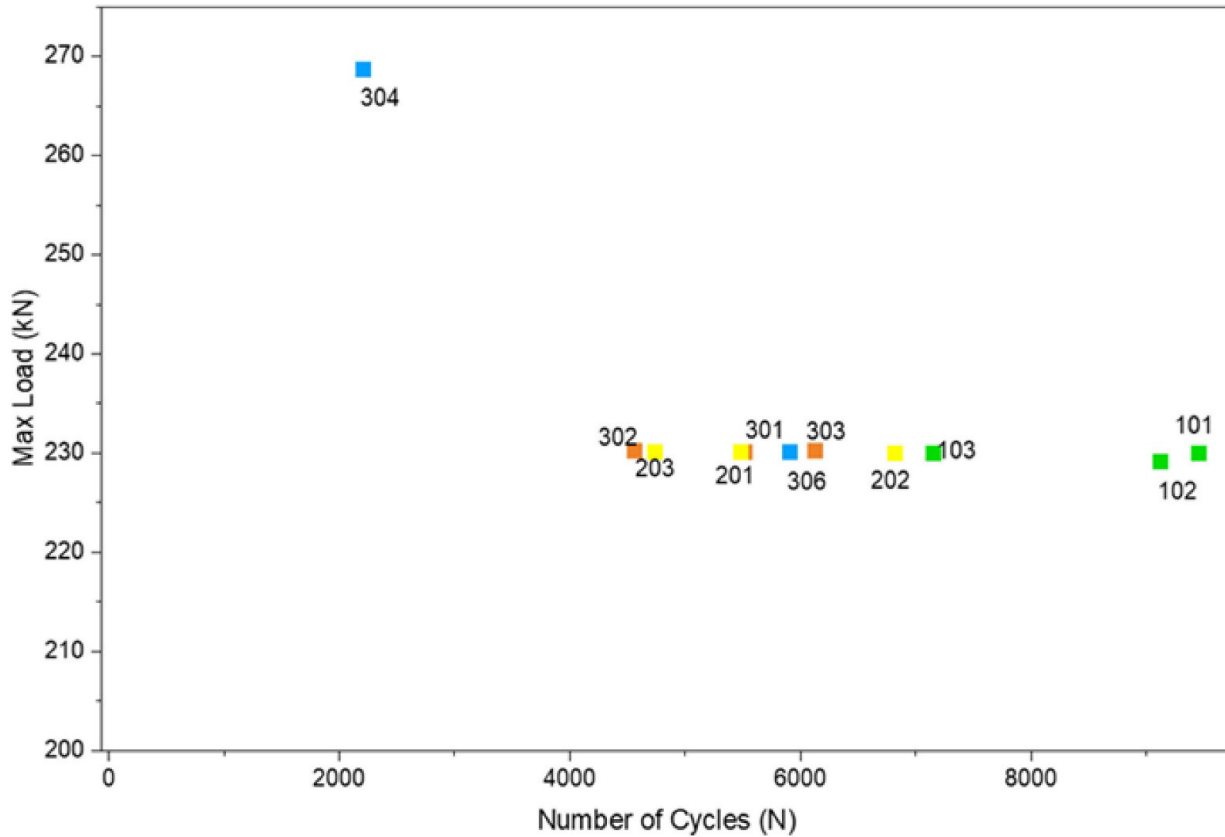
Figure 4 Fatigue life comparison graph.

M36 baseline S355 (Group 3): 5,916 cycles (single specimen)

M36 SAE 1045 (Group 1): 5,395 ± 791 cycles

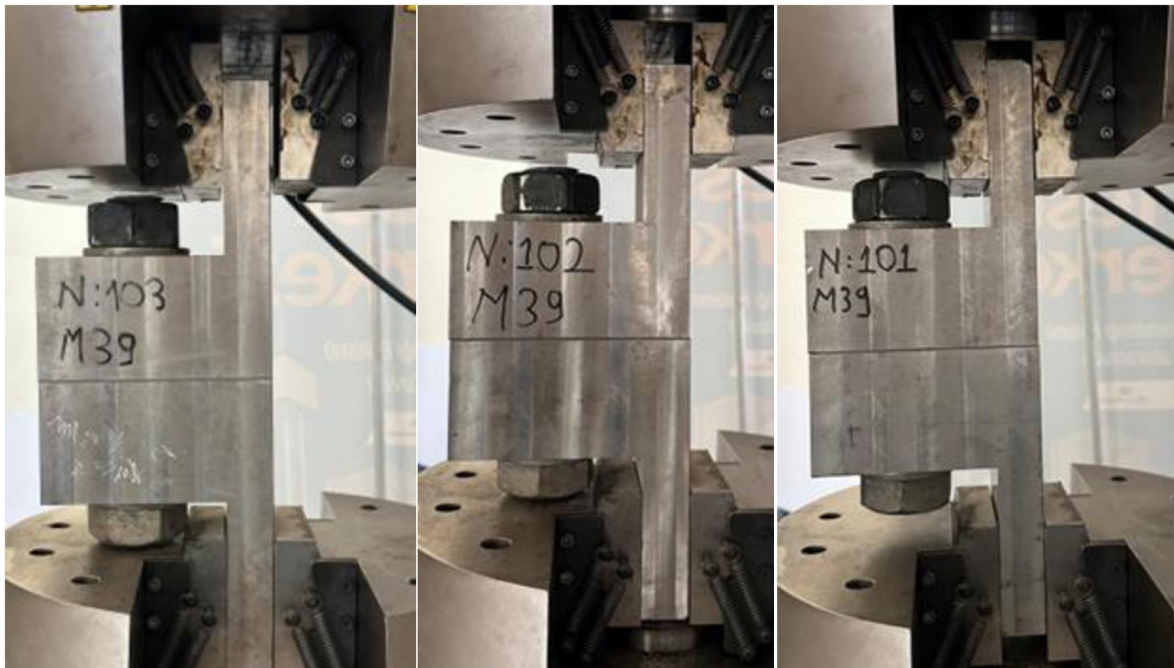
Figure 5 Pre-fatigue test appearance of N101, N102, N103 specimens with M39 bolts.

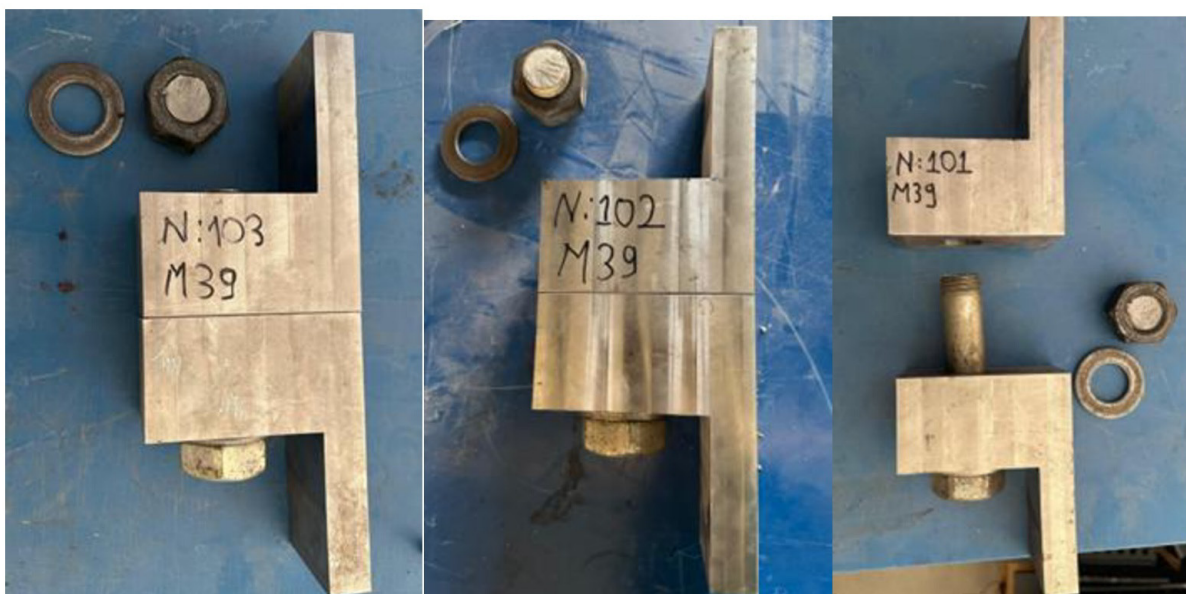
All M39 specimens exhibited classic bolt shank fatigue fracture with crack initiation at thread root region, progressive crack growth evidenced by beach marks, and final rapid fracture zone occupying 30-40% of cross-section. No thread stripping or nut damage was observed.

Figure 6 Post-fatigue test appearance of N101, N102, N103 specimens with M39 bolts.

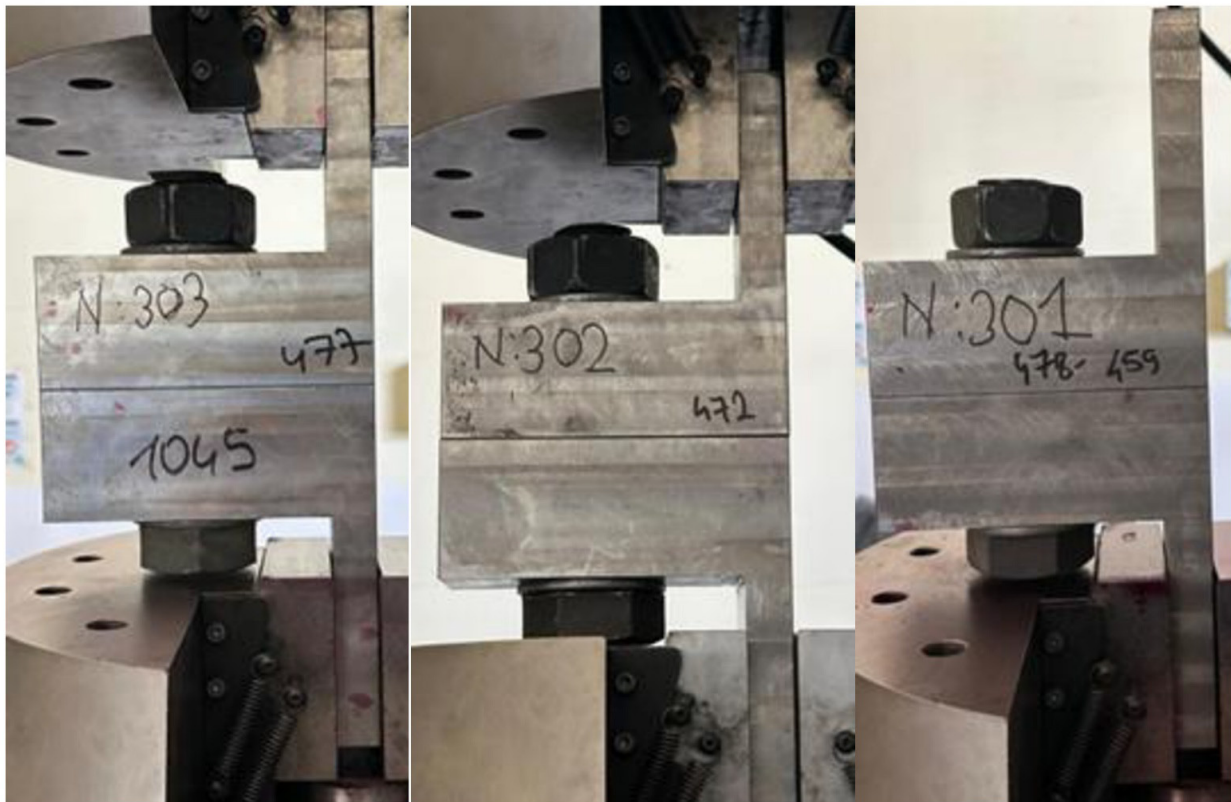
Figure 7 Pre-fatigue test appearance of N301, N302, N303 specimens.

SAE 1045 carbon steel (high strength, low ductility) exhibited characteristic brittle fracture behavior with sharp, clean fracture surfaces showing minimal plastic deformation, limited flange bending with elastic-dominated response, and multiple sharp radial cracks propagating from bolt holes with minimal crack tip blunting. The 7-9% elongation capacity (Isik and Alemdar, 2025) resulted in limited energy dissipation prior to final fracture, consistent with brittle failure modes observed in high-strength, low-ductility steels under cyclic loading (Grismo et al., 2016; Plaitano et al., 2022).

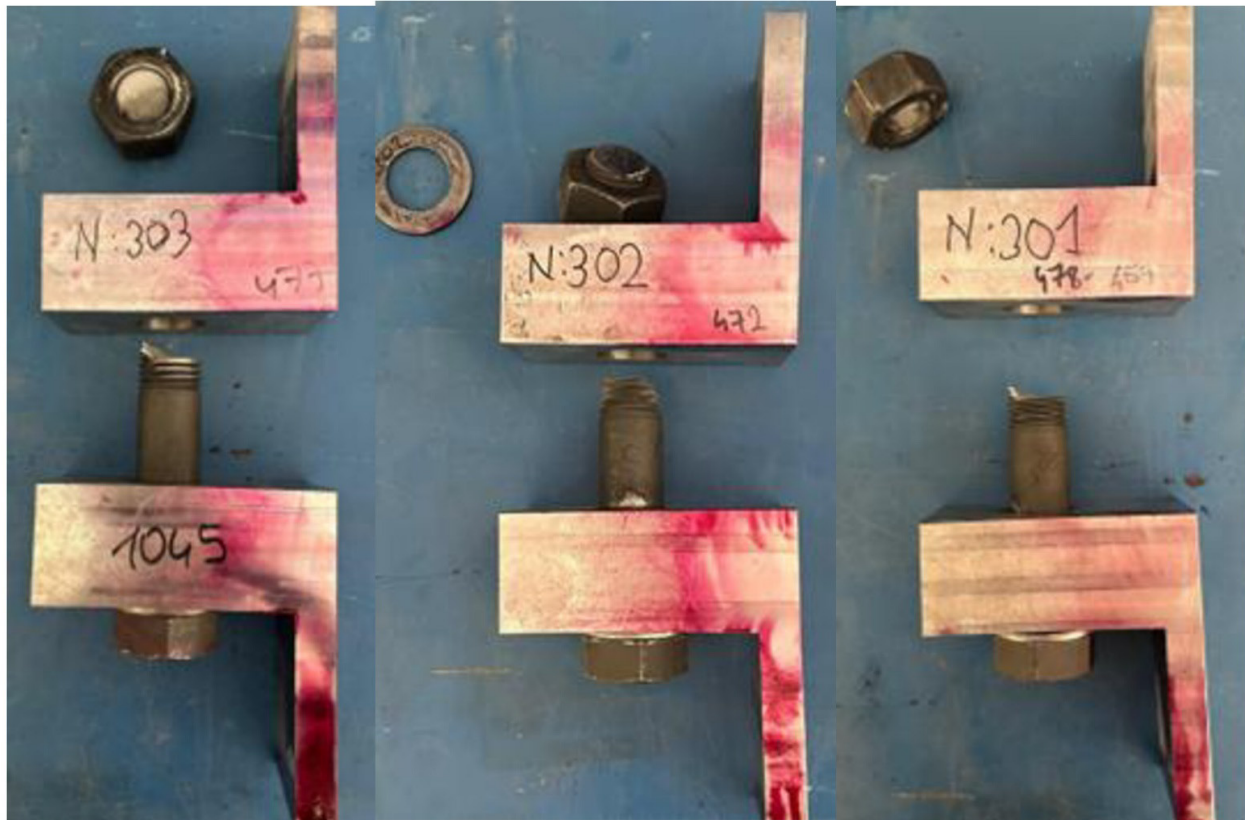
**Figure 8** Post-fatigue test appearance of N301, N302, N303 specimens.

In contrast, S355 structural steel (moderate strength, high ductility) displayed ductile fracture characteristics including more diffuse fracture surfaces with evidence of substantial plastic deformation, noticeable flange bending and yielding concentrated near the bolt hole region, and fewer but wider cracks with visible plastic zone development around crack tips. The superior 18-19% elongation capacity (Isik and Alemdar, 2025) enabled progressive damage accumulation with visible warning signs, consistent with ductile fracture behavior documented for structural steels (Johansen and Waldeland, 2016; Alonso-Martinez et al., 2018).

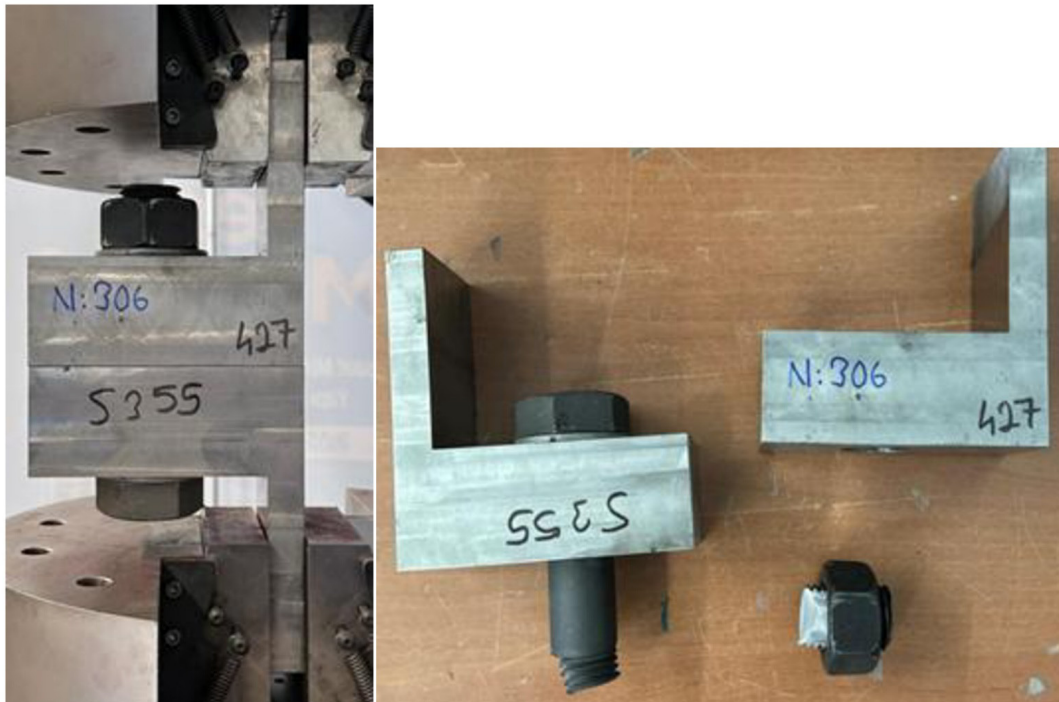
Figure 9 Pre and Post fatigue test appearance of N306 specimens.

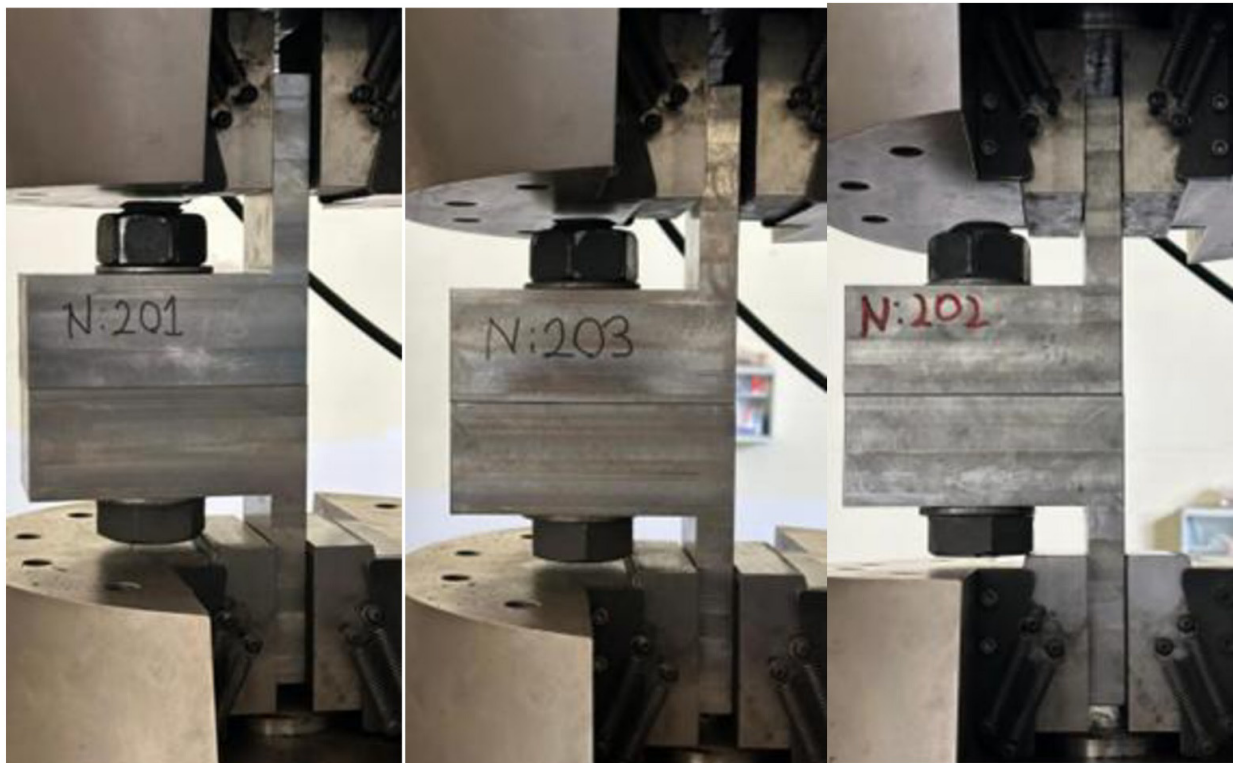
**Figure 10** Pre-fatigue test appearance of N201, N202, N203 specimens.

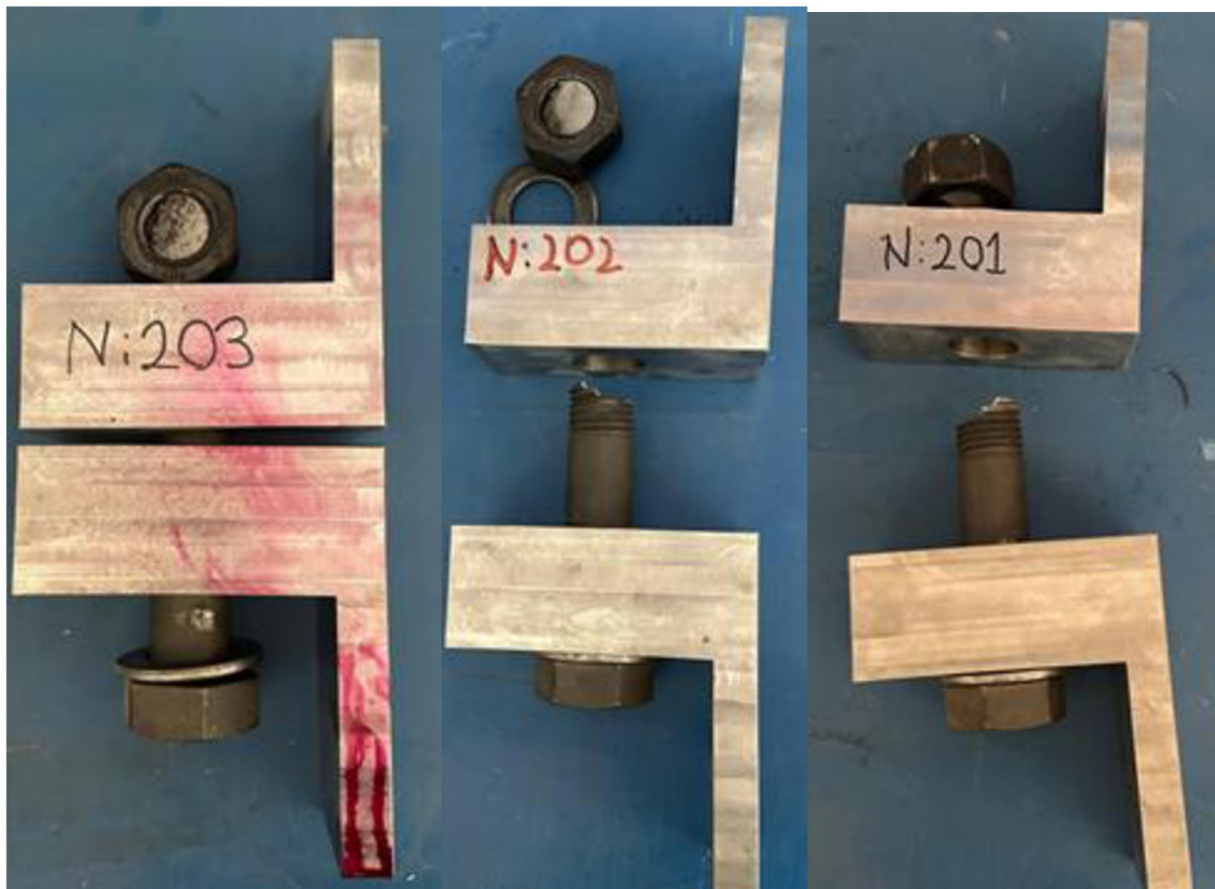
**Figure 11** Post-fatigue test appearance of N201, N202, N203 specimens.

Unlike centric tests where all specimens exhibited pure bolt fracture, eccentric loading produced mixed failure modes. Specimen N:201 showed combined flange and bolt failure, N:202 exhibited bolt shank fracture only, while N:203 shown combined failure with severe local flange buckling. Pre- and post-test appearances Figures 18-19 clearly illustrate these contrasting damage patterns.

Eccentric loading induced additional flange damage mechanisms including local yielding and indentation around bolt hole bearing surface, out-of-plane bending causing measurable flange curvature 3-10 mm deflection, and secondary crack networks in flange material emanating from highly stressed regions. These observations indicate that eccentric loading fundamentally alters the system-level load path and introduces failure modes extending beyond simple bolt fatigue.

Eccentric loading produced combined bolt-flange failure in specimens N:201 and N:203, characterized by local yielding around bolt hole bearing surface, out-of-plane flange bending (3–10 mm deflection), and severe local buckling in N:203. This altered failure mode under eccentric loading conditions confirms the significant influence of load path irregularities on system-level connection behavior, consistent with findings by Van-Long et al. (2013) and Seidel and Schaumann (2021) on the importance of geometric imperfections in bolted flange connections.

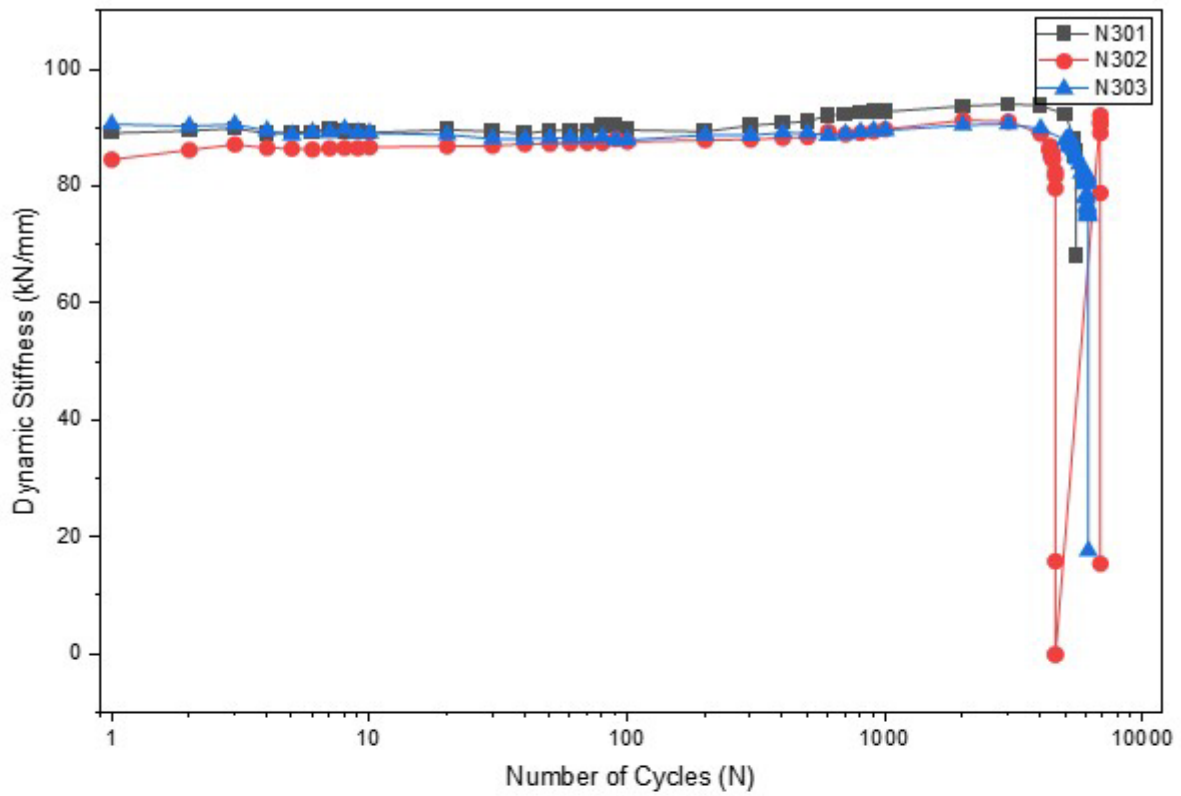
Figure 13 Dynamic stiffness vs. cycle count for Groups 1 and 3.

Comparing degradation characteristics across test groups reveals distinct stiffness evolution patterns. M39 bolts Group 4 exhibited lower total stiffness loss 18-21% compared to M36 configurations 22-29%, with more gradual degradation patterns and extended Phase 1 duration. This behavior indicates that larger bolt diameter not only provides higher absolute fatigue life but also delays crack initiation, resulting in a larger proportion of life spent in the stable low-damage regime. Conversely, eccentric loading Group 2 produced highest total stiffness loss 24-29% with more irregular degradation patterns featuring sudden drops corresponding to discrete flange yielding events. The onset of Phase 2 degradation occurred earlier approximately 75% of life compared to concentric loading 80%, reflecting the additional damage mechanisms introduced by bending moments and flange plasticity.
