# CFRP repair effectiveness on compressed steel tubular members with circular cutout

Corroded structures; Composite material repair; Steel tubular members.

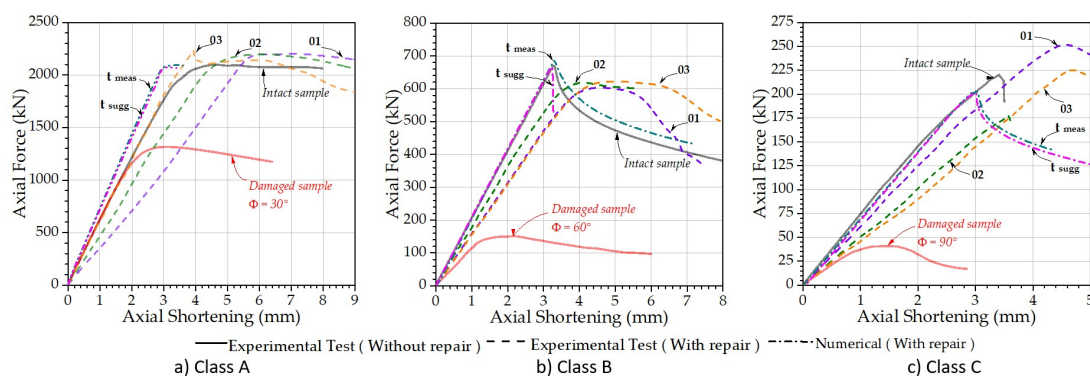
The adopted nomenclature for sample identification is: Material type (I, II and III), Tube class (A, B and C) and sample specification (01, 02 and 03), this latter represents the tubes tested at operating temperature for each type of material. It can also be seen the results of the numerical simulations with the suggested repair thickness of the composite laminate as  $t_{sugg}$ , and with the average thickness of the repairs measured in the samples as  $t_{meas}$ . **Figure 7** shows the Force-Displacement curves for numerical and experimental samples repaired with material type I. The maximum compression capacity, from numerical predictions and experimental measurements, of the samples of Class A, B and C reported close values with differences within the range of -4% to 1%, 4% to 14%, and -20% to 1%, respectively. The smaller capacity reported in sample Class C-02 (-20%) was due to the repair thickness being smaller than suggested. In general, repaired samples reported a recovery of the compressive capacity of ~96% of the intact condition, except for the tube Class C-02, suggesting a good performance of the laminate repairs. The effect of the operating temperature resulted in a reduction of the axial elastic stiffness in all samples, as well as a small influence on the maximum capacity load, decreasing approximately 8% in relation to the repaired tubes, except for the Class C-02 sample.

**Figure 7:** Load-shortening curves of samples repaired with material I.

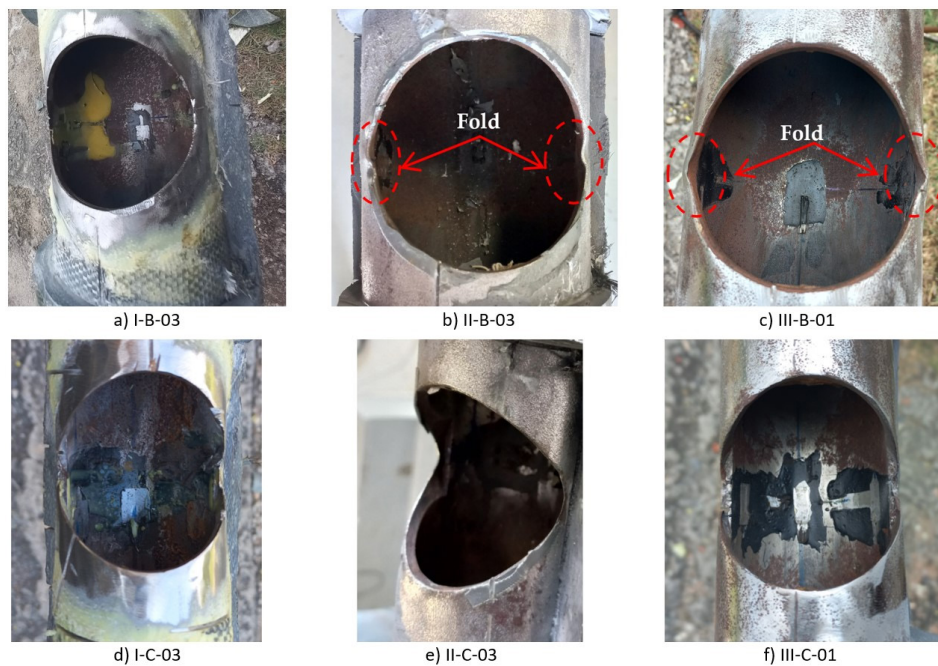
Similar to class A samples, the composite laminate was dissected in the damaged region of tubes B and C for each type of repair material (see **Figure 16**). The comparison of failure modes of samples I-B-03, II-B-03 and III-B-01 is presented respectively in **Figure 16a-c**. In the repair with type I material, no folds were identified on the sides of the perforation, nor significant ovalization. In repairs with materials II or III, a small level of fold was identified on the sides of the perforation, as well as lower recovery of the compressive load (**Figure 16b,c**). Likewise, the failure modes of samples I-C-03, II-C-03 and III-C-01 are shown respectively in **Figure 16d-f**. In these tubes class, the post-failure is characterized by folds close to the perforation without repair. In all the images it is observed that the folds do not appear, which means that the repair prevented the development of this failure mode.

**Figure 16:** Localized buckling for samples of tubes from classes B and C.
